Post Installation Performance of Cavity Wall & External Wall Insulation

St George's Hotel, Llandudno

BRE: Post Installation Performance of Cavity and External Wall Insulation

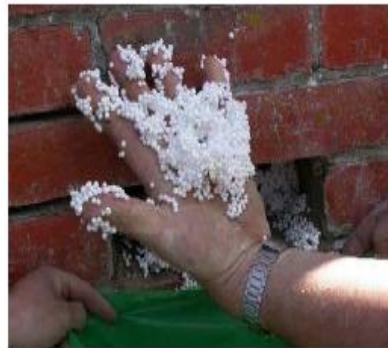
Figure 3: Example of saturated insulation

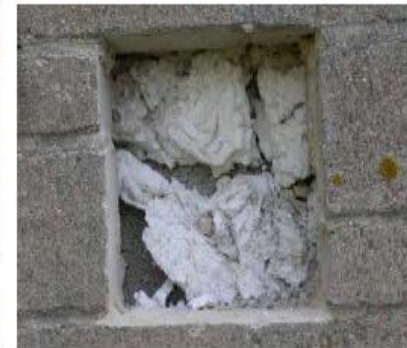
Figure 4: Example of saturated insulation

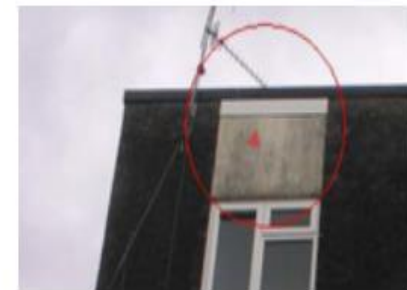
Many of the properties had experienced damage and deterioration as a result of the exposure to the weather. Mortar and bricks used in the construction are already saturated, with discolouration and mould growth evident. Examples are shown in Figures 5 & 6 below.

Figure 6: mould on saturated render panels

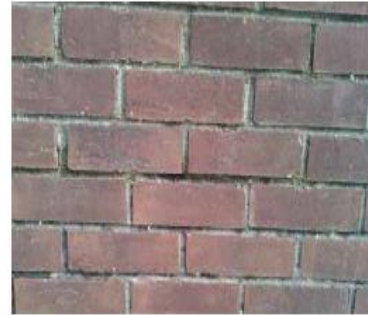
Figure 11: Erosion of mortar by weather

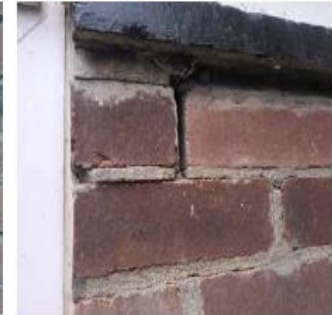
Figure 12: Cracked and missing

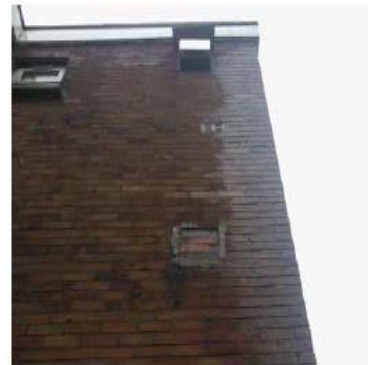
Other issues were identified where rainwater has overblown the roof and has saturated elements of the wall as shown in Figures 13 & 14 below.

Figure 13: Wall staining from water blown off the roof

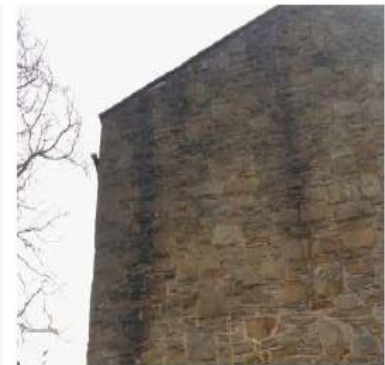
Figure 14: Staining from roof water run off

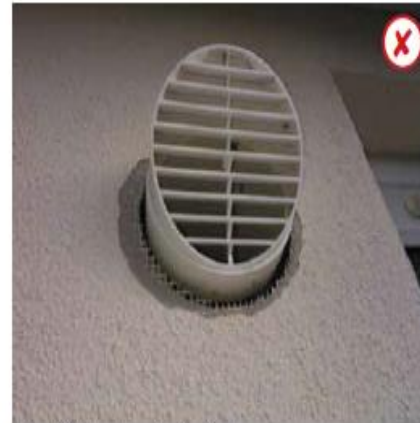
Figure 34: Unsealed extract fan in a bungalow

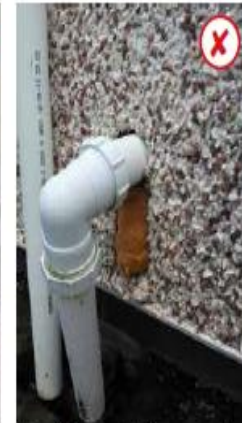
Figure 35: Unsealed pipe penetration

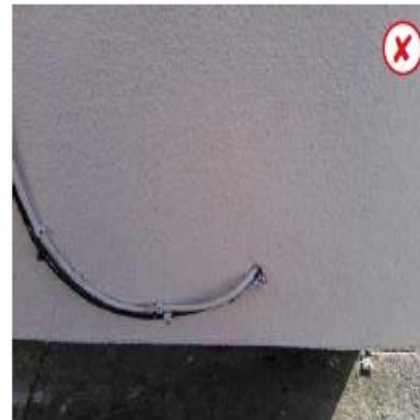
Figure 36: Unsealed wire penetration

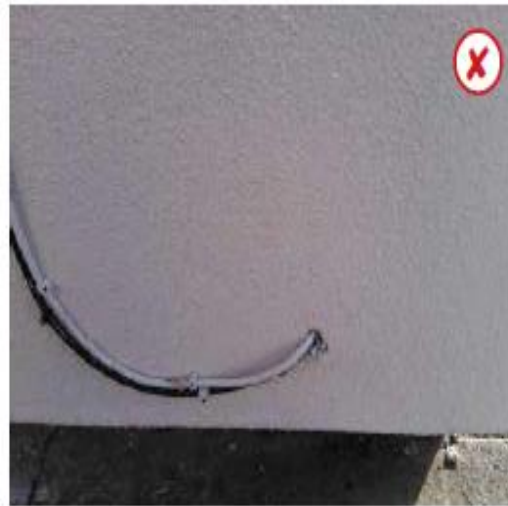
Figure 38 – cable clipped

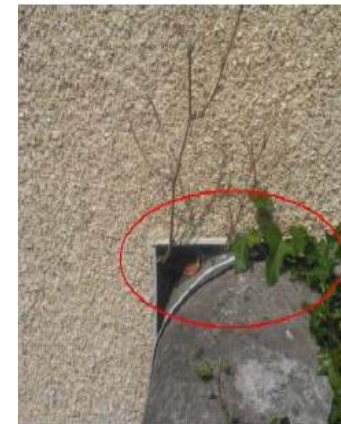
Figure 48: Plant growth allowed by poor detailing

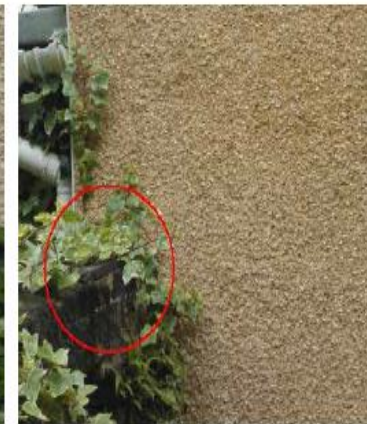
Figure 49: Close proximity of plant requiring pruning

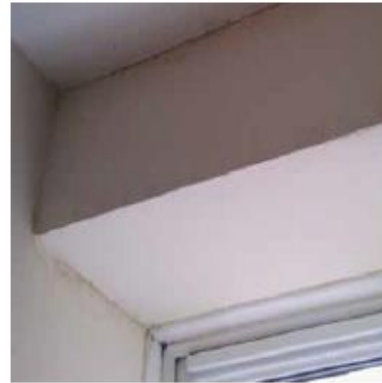
Figure 50: Damp in the kitchen

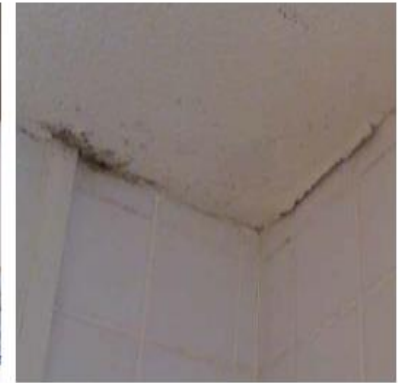
Figure 51: Damp in the bathroom

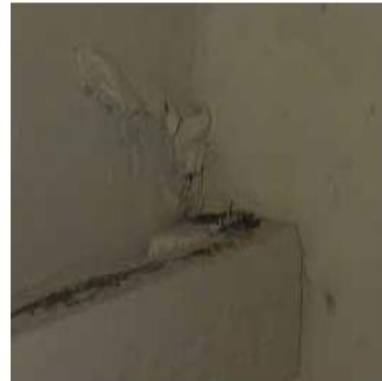
Figure 52: Damp in the wardrobe

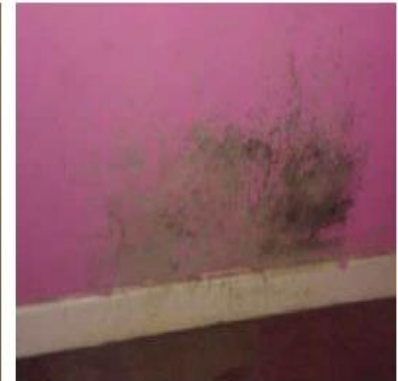
Figure 53: Damp behind a bed, removed for inspection

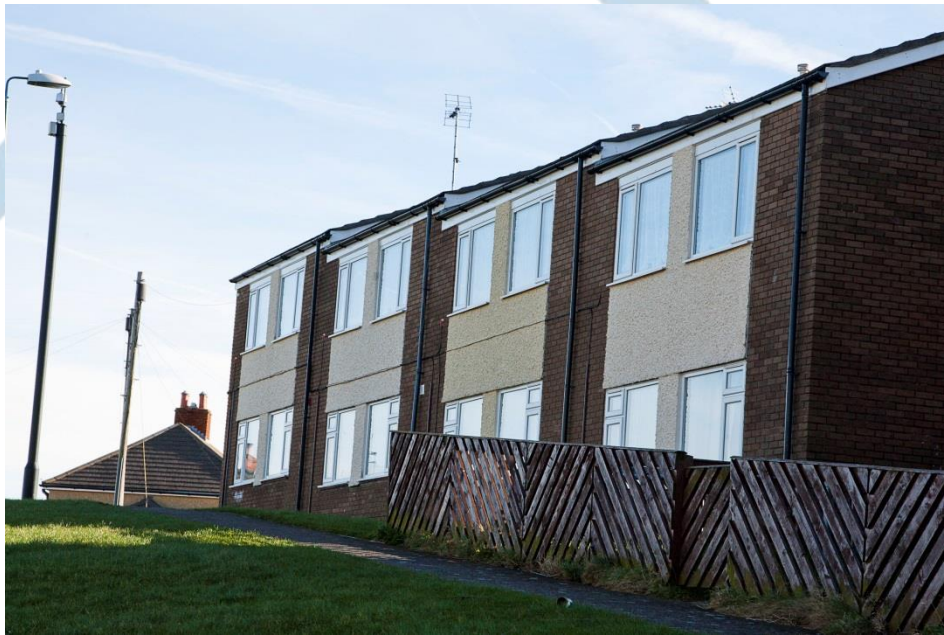
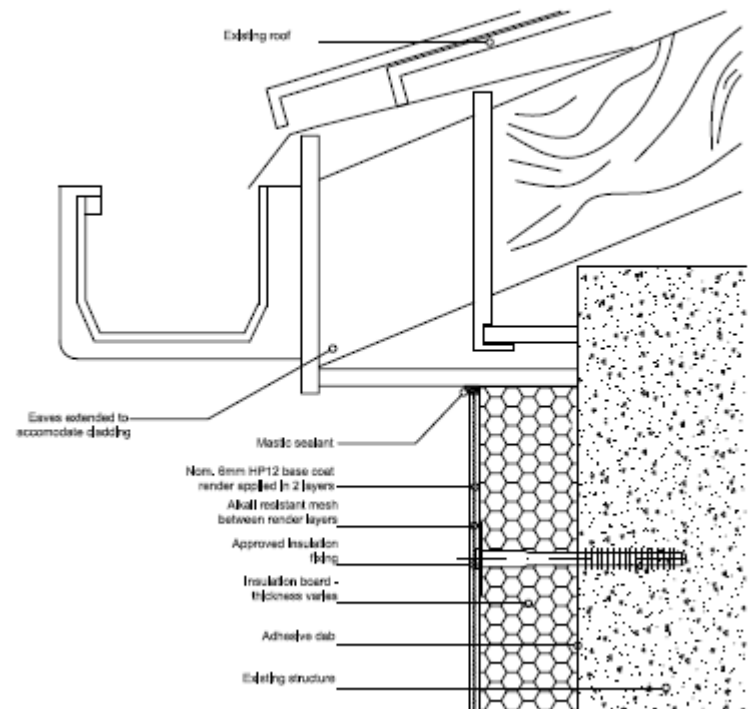
1. Insufficient eaves and gable overhangs

Extend the roofline

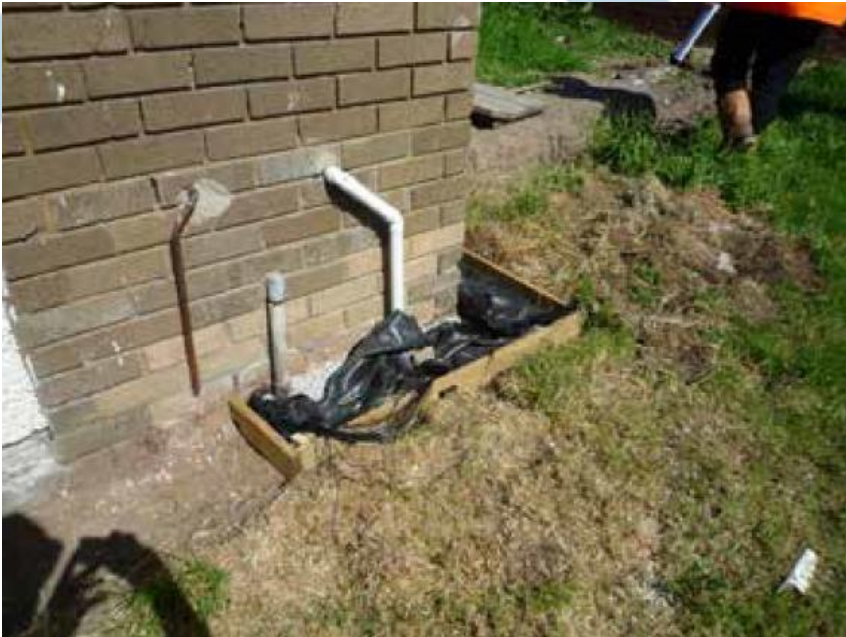
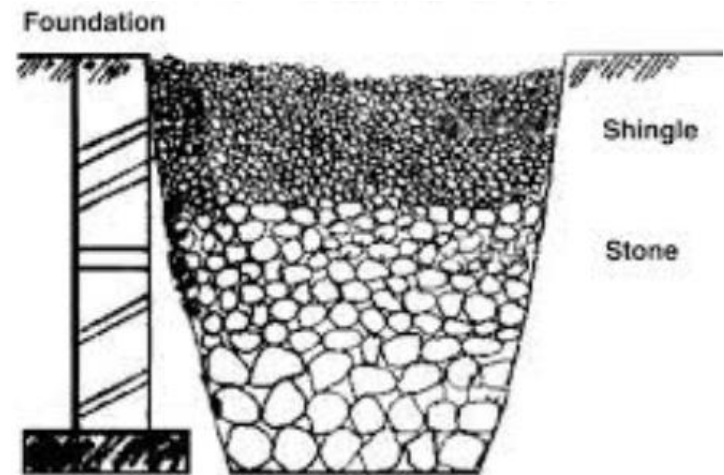
2. Ground levels bridging DPC

Insert draining trench

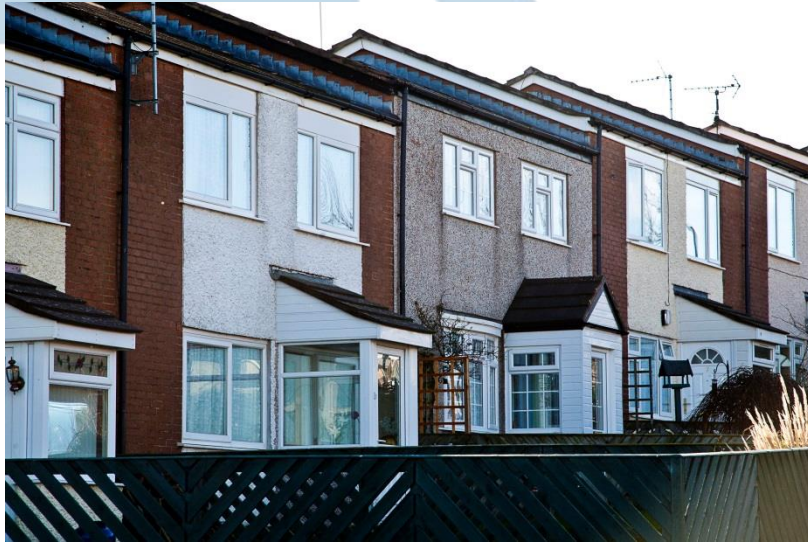
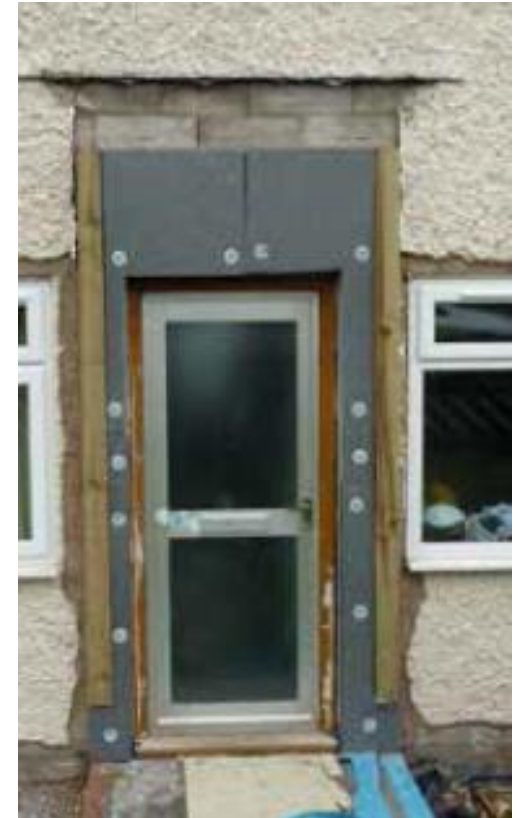
3. Cold bridging to existing porches

Remove, insulate and replace

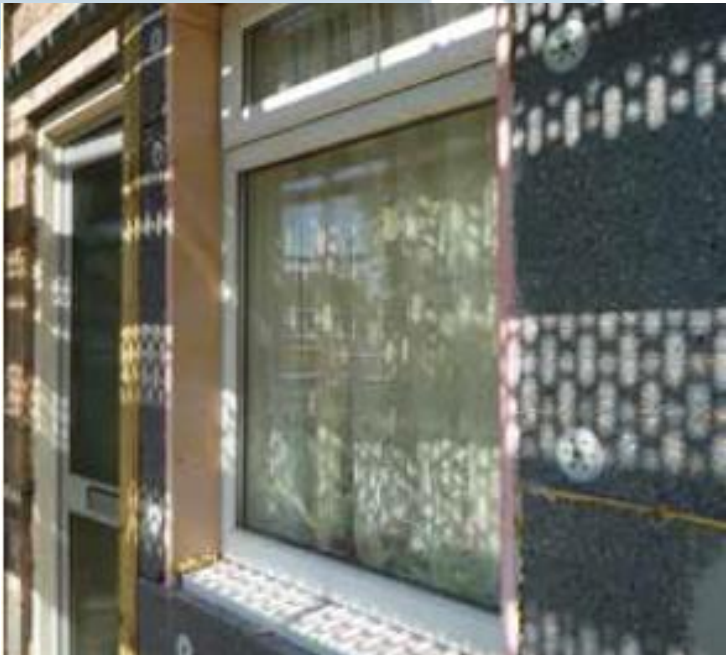
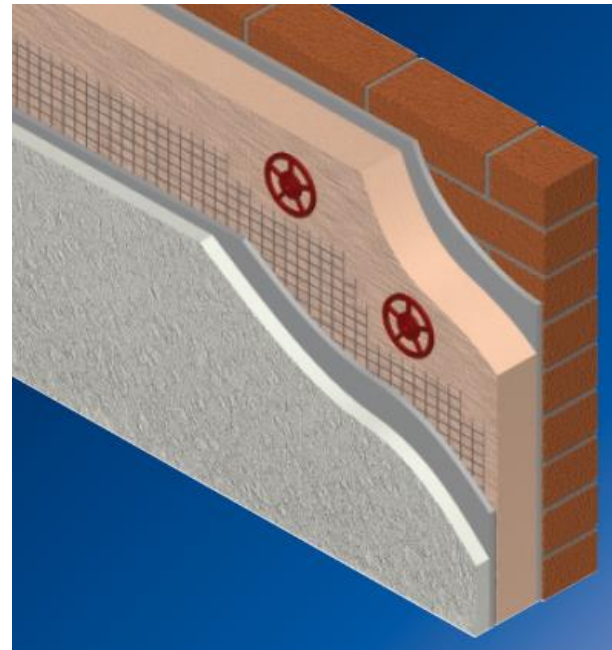
4. Cold bridging to window reveals

Use of thinner high performing insulation
