BRE: Why do we need a different approach

Colin King

Date 2017

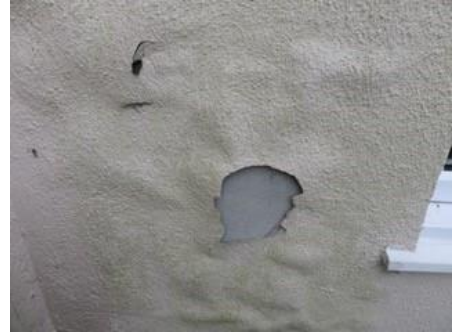
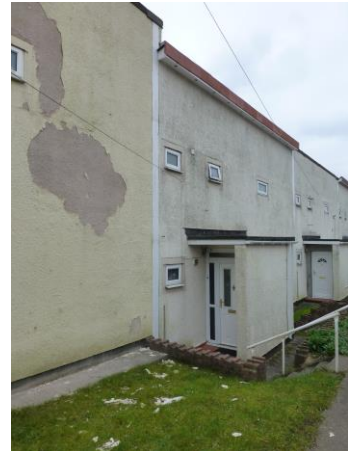
- **External insulation**
- *Initial Preparatory Works*
- Inconsistent identification/removal of areas of delaminated render (pre-installation)
- Limited assessment of characteristics of building and siting prior to specification
- Signs of movement in building ignored
- Parge coating essentially never undertaken, regardless of wall surface introducing micro cavities

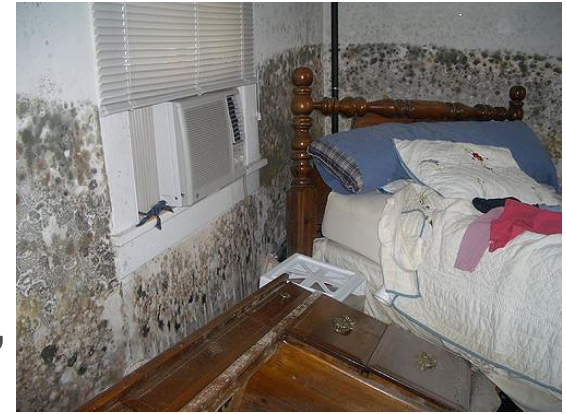
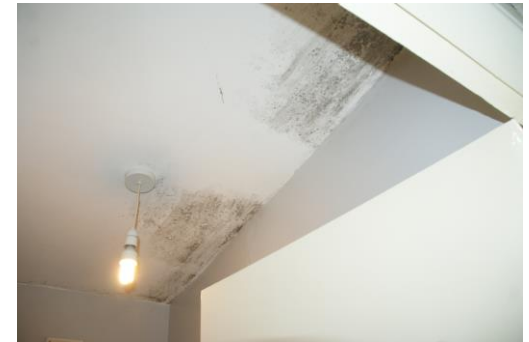
- Detailed assessment of moisture content in the structure, evidence of condensation and mould ignored
- No assessment of ventilation provision in place, including the presence of trickle vents, working mechanical extraction, or delivered extraction rates, or availability of opening windows.
- Local climatic conditions not fully considered (wind driven rain, exposure etc.)

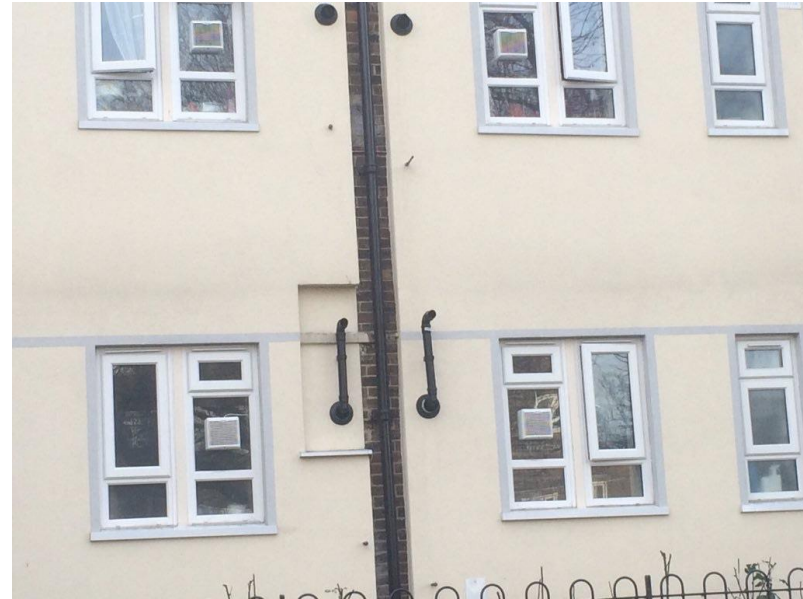
- *Design Weakness*
- Reveals and other two dimensional junctions not considered or included in the proposed scheme and then not insulated
- Meter boxes left in place, services boxed around rather than moved to outside of system
- Significant thermal bridging left at eaves – both with soffit and without. Heads of top-floor windows often left uninsulated if at roof level

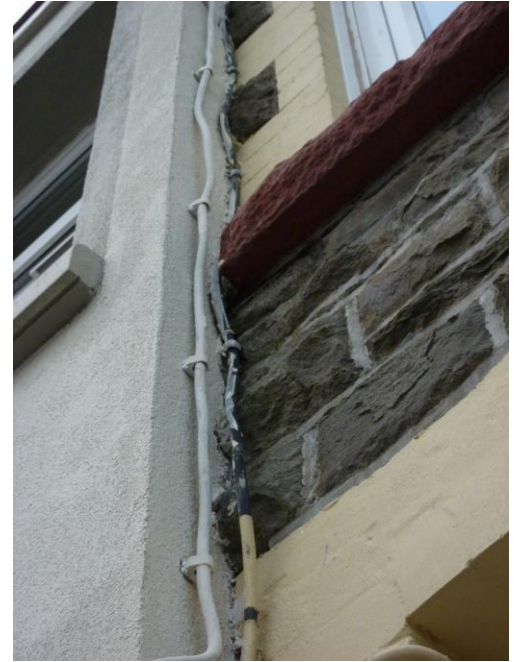
- Thermal bridge at area over porch roofs, etc. (often >100mm left uninsulated to reduce rain splash-back dirtying render and saturation from snow)
- Flashing over conservatories, shed roofs, etc. not boarded over with insulation, instead insulation is left above level of flashing
- No insulation below DPC (often starts 50mm above)
- Gaps in insulation around services

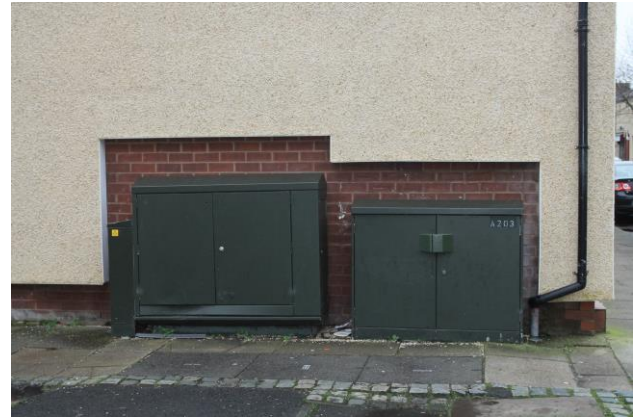
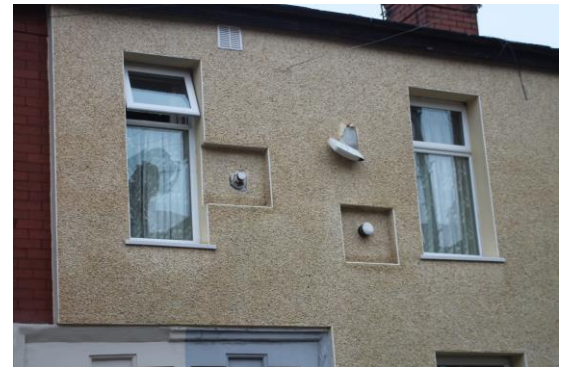
- Fences, gates and other abutments not isolated from the building to allow the insulation to be continuous.
- Introduction of conductive material (metal) into system designs, resulting in introduced cold bridges.
- Poor details produced at roof line and gable end, resulting in the use of mastic sealant to deliver the water resistance strategy.

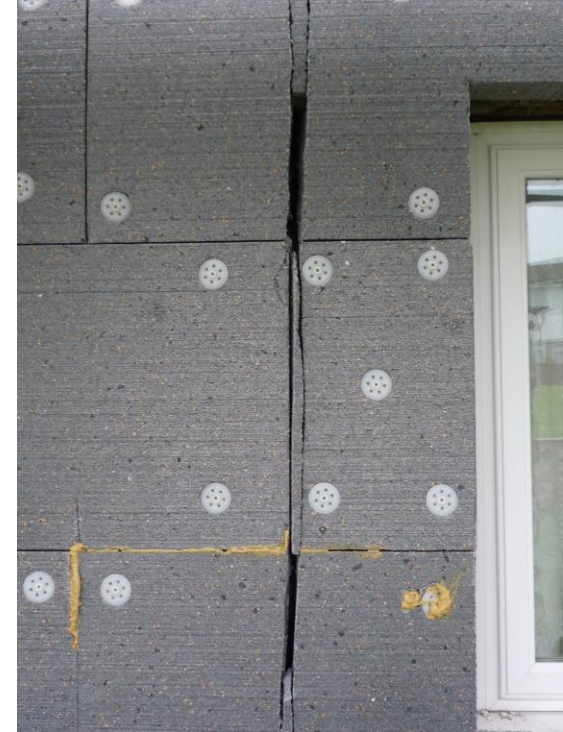
- *Inconsistent Workmanship*
- Weep holes/channels of windows covered by oversills
- Gaps between boards, at times up to 10-15mm
- Mesh not fully embedded
- Stress patches of inadequate size
- Bond pattern of boards not in line with spec (e.g. <200mm vertical edge to vertical edge between courses)
- Fixings: specified pattern not followed, over drilled, over sunk, etc.

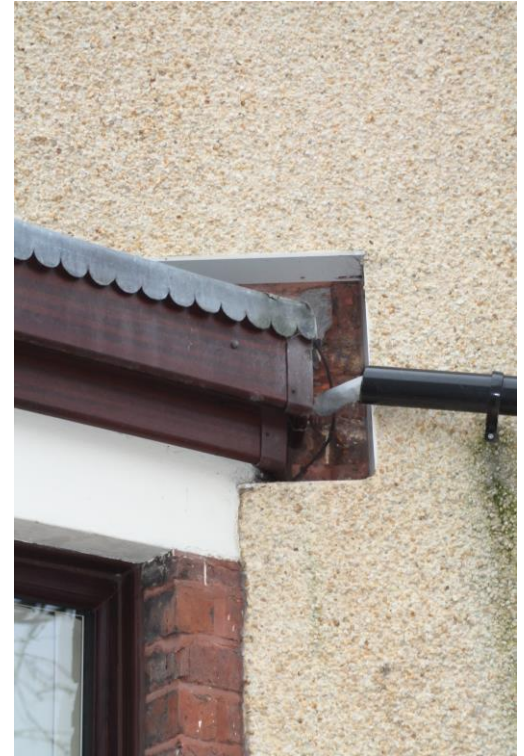
- Adhesive (where specified) not applied consistently to board
- Inconsistency of pattern placement for hanging baskets, etc.
- Sills, verge trim, etc. not adequately sealed, or mistakenly left unsealed
- Capillary grooves on sills compromised
- System stops, base rail, trim etc. not firmly fitted
- Poor/no ground clearance, particularly around doorsteps, ramps, etc.
