Building Better Buildings

22nd March 2016

Building Performance Evaluation: In-use Post Occupancy Evaluation – a Welsh Case Study

Building Performance Evaluation

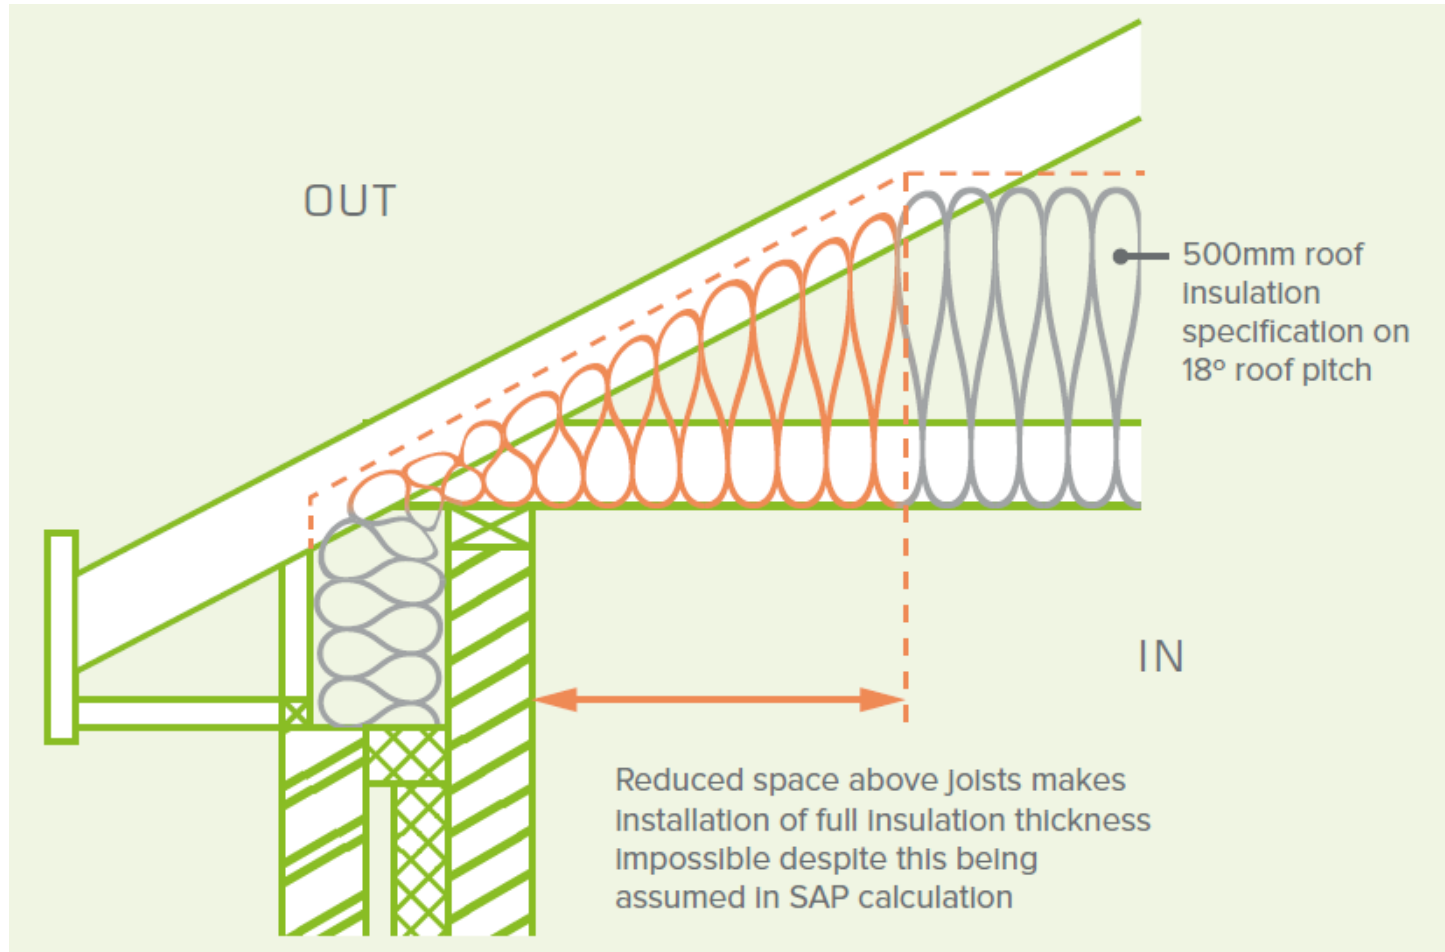
How is the u-value calculated?

Can't assume same thickness across entire roof

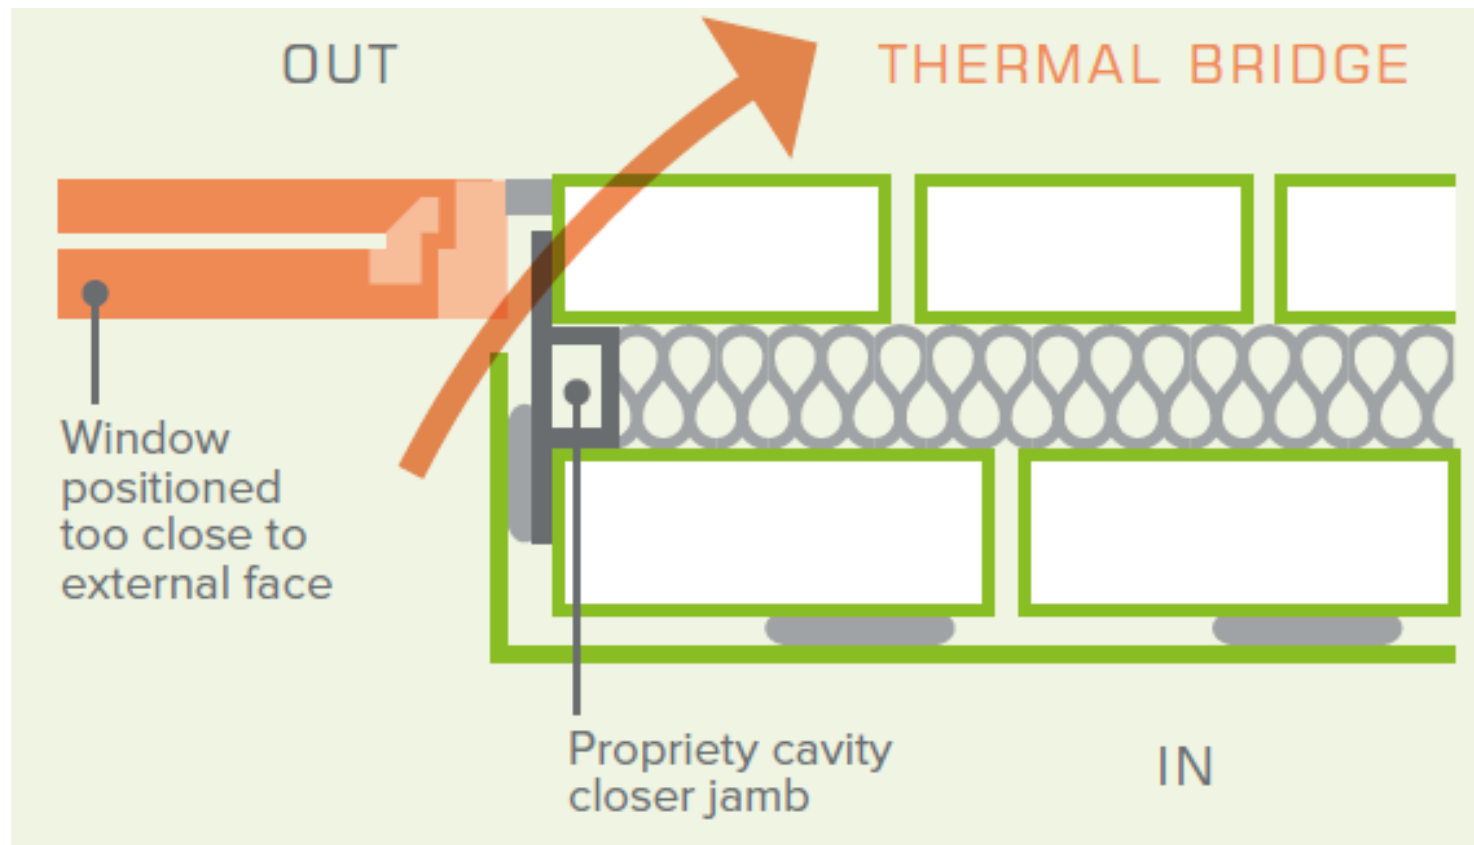
Windows located in front of design positions

- Insufficient overlap with cavity closer
- All sites visited had the window in the wrong place

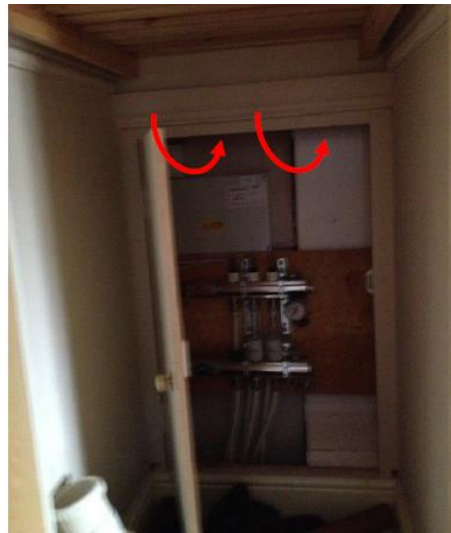
Heating, Thermostats, Occupants or Fabric causing inadequate performance

As Built Air Permeability - 2010	Air Permeability 2014 Test Result	Difference
Flat	2.9 m ³ / (h.m ²)@50Pa	3.72 m ³ / (h.m ²)@50Pa	+0.82 m ³ / (h.m ²)@50Pa
House	4.8 m ³ / (h.m ²)@50Pa	8.8 m ³ / (h.m ²)@50Pa	+4.00 m ³ / (h.m ²)@50Pa

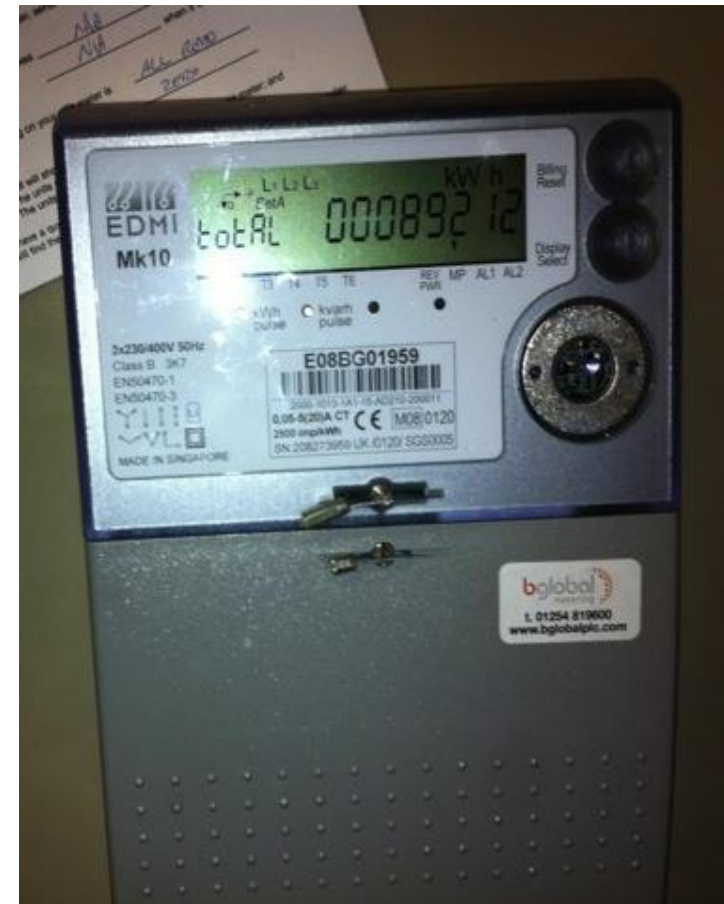
Metering and BMS

- 6 zones all sub-metered for electricity and heat

- Electrical sub-meters not properly commissioned
- Gas meters not properly calibrated
- Heat sub-meters not capable of communicating with BMS
- BMS not correctly reading electrical meter pulses

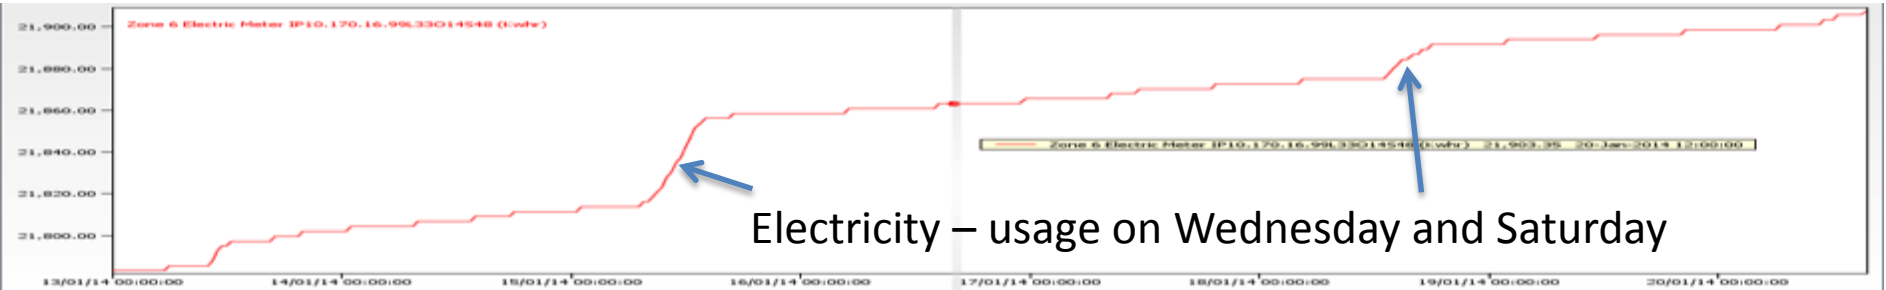
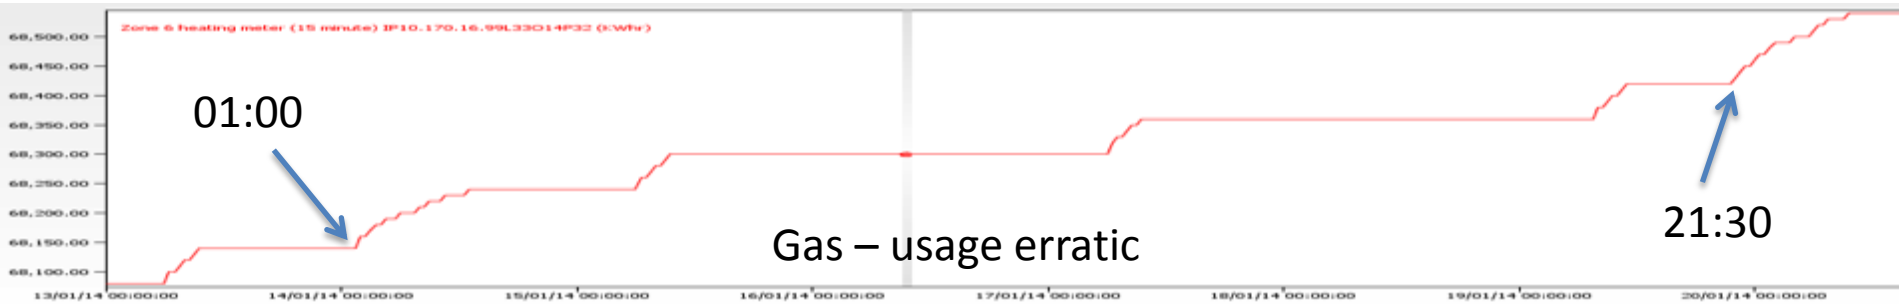
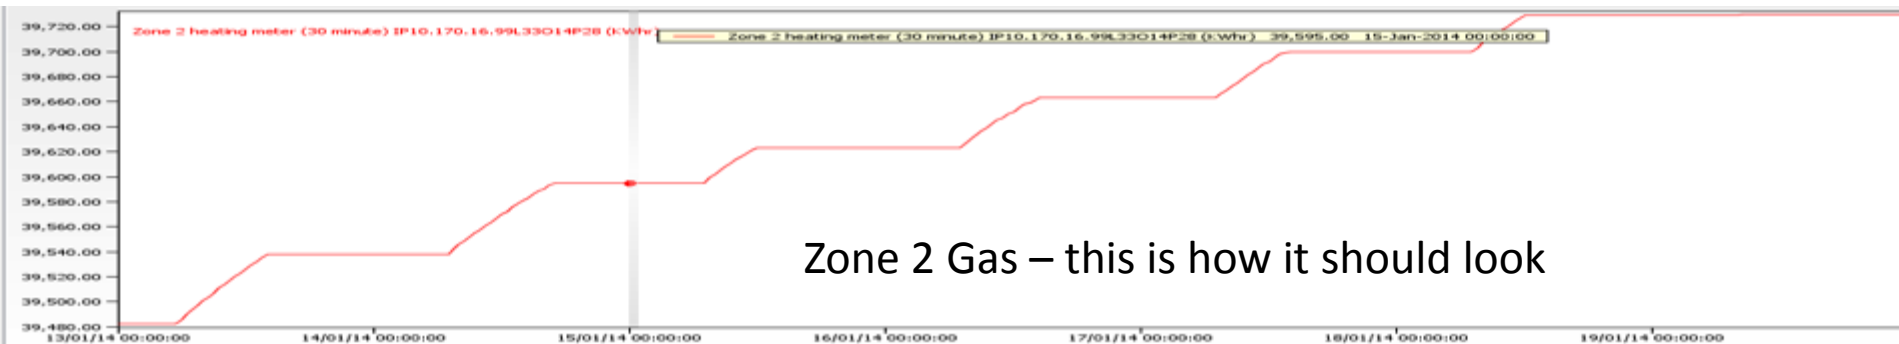
Zone 6 Heating

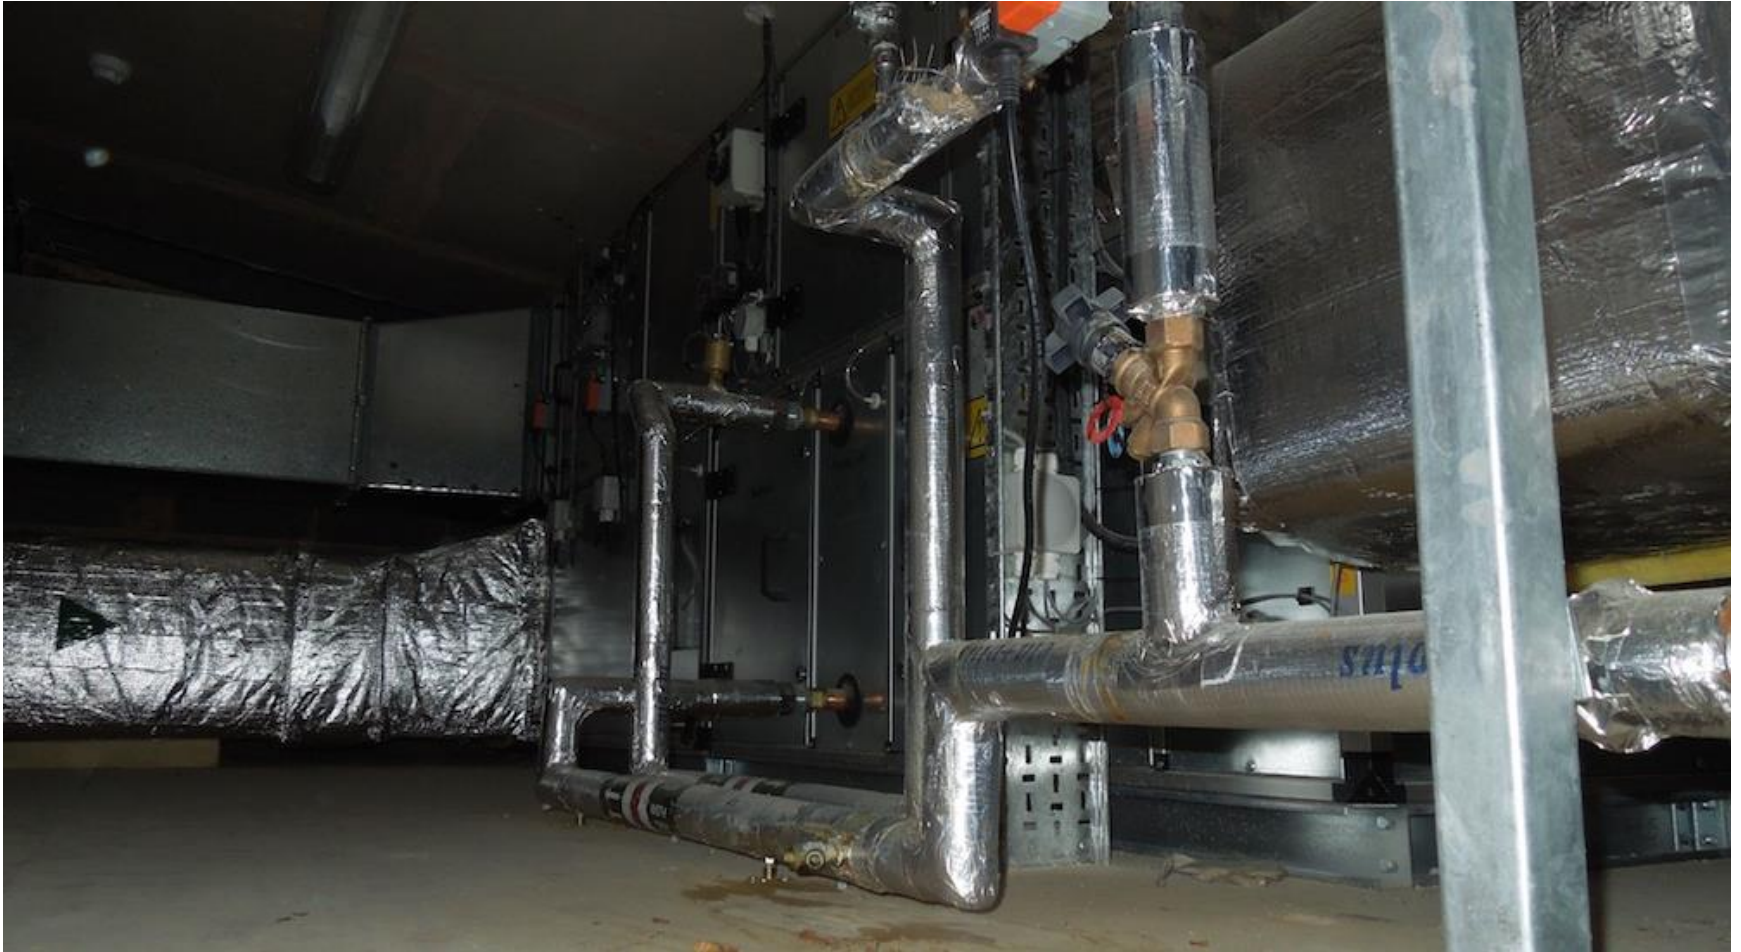
Air handling unit heater & frost protection

Options:

Drain system, remove heater, re-route circuit (£2600)

Change frost protection settings (within project cost)

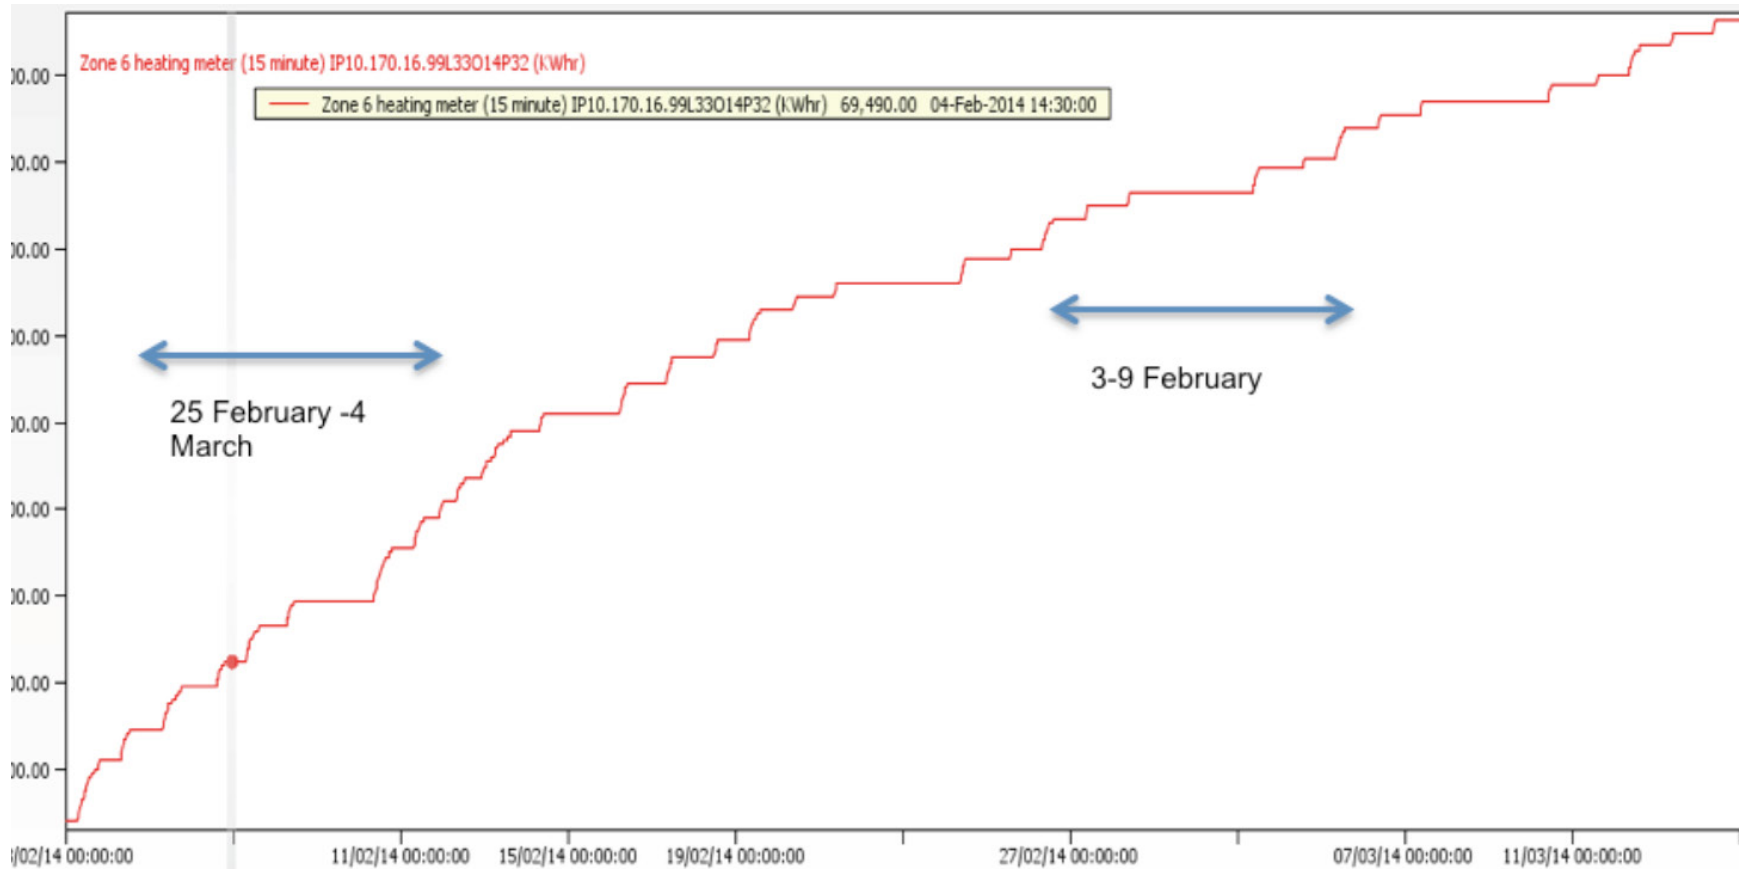
Changes to frost protection

Extrapolated to the year 9000kWh or ~£250

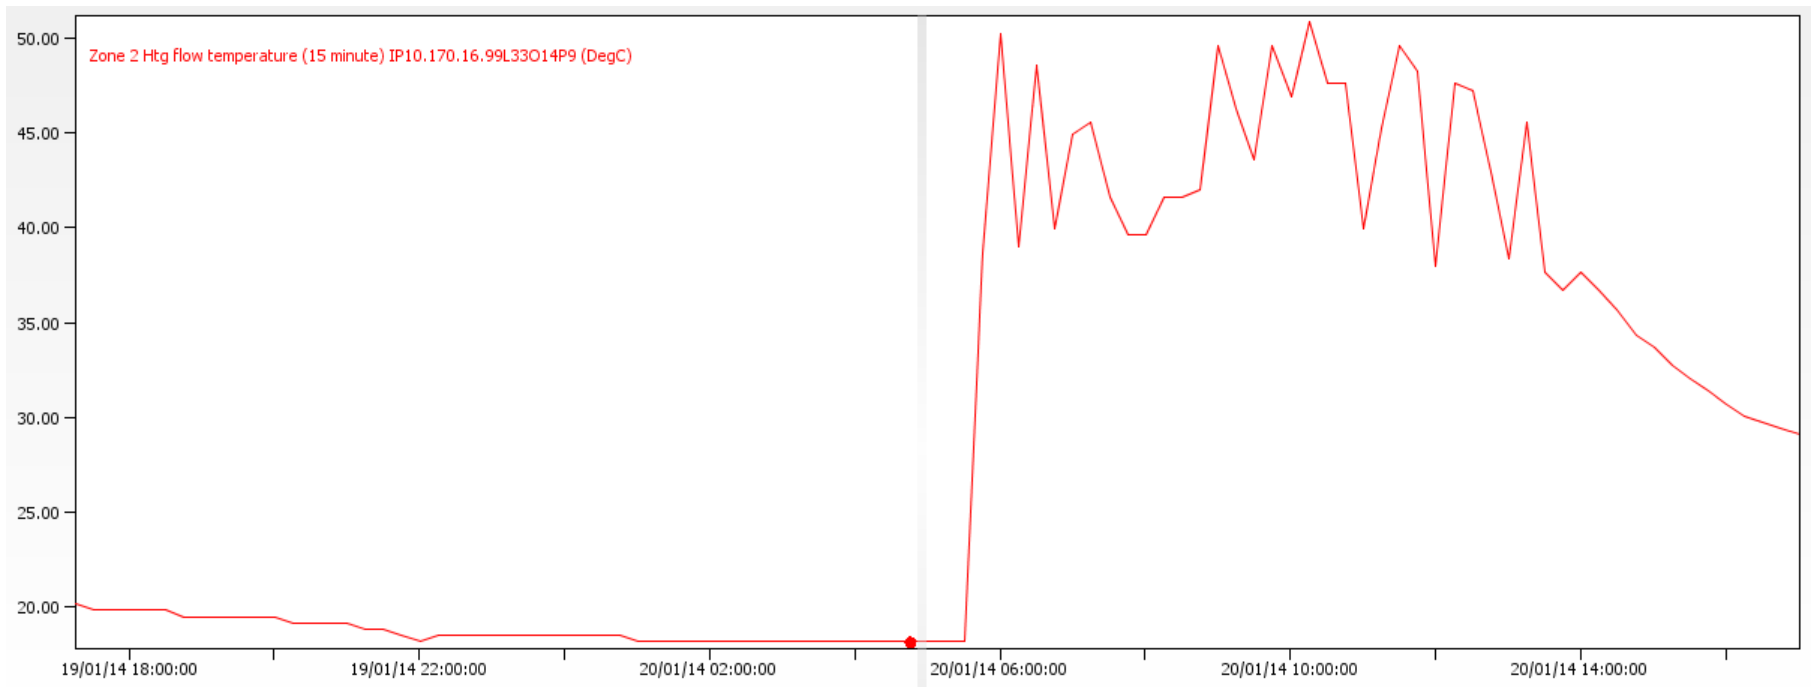
Zone 2 - Library Heating

- UFH & radiators on same circuit
- Radiators running at $\sim 50^{\circ}\text{C}$

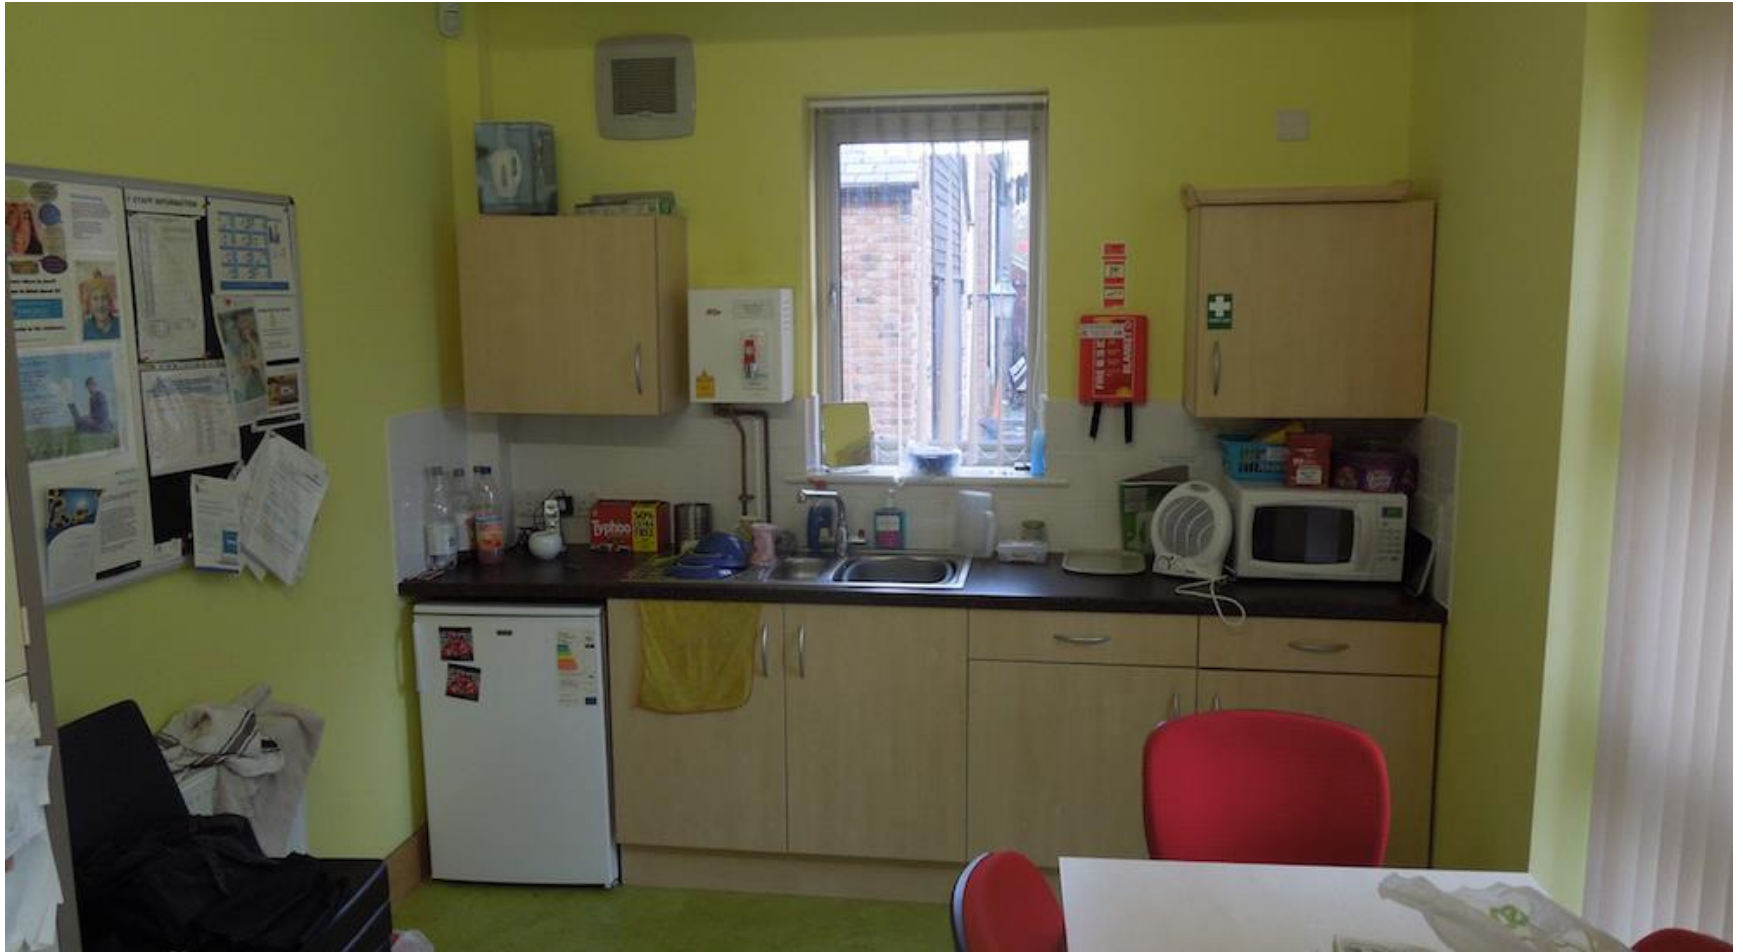
Zone 2 electric heaters

- ~£189/yr additional cost of electricity for fans
- £3200 to install thermostat on UFH manifold and reprogramme BMS to provide 70°C water to radiators (not done)

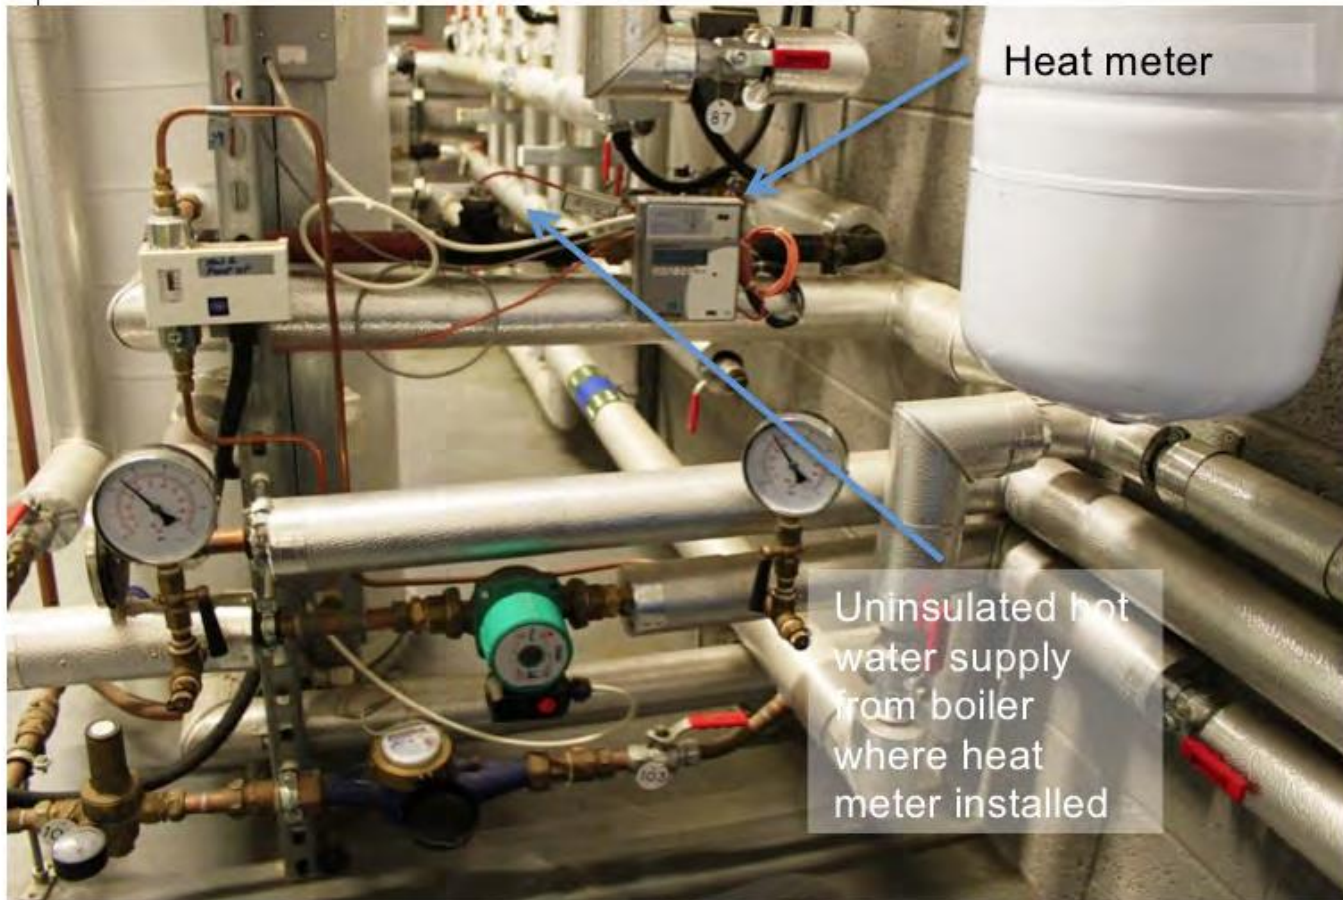
Zone 1 Domestic hot water (DHW) & solar thermal

Note also numerous uninsulated valves and gauges

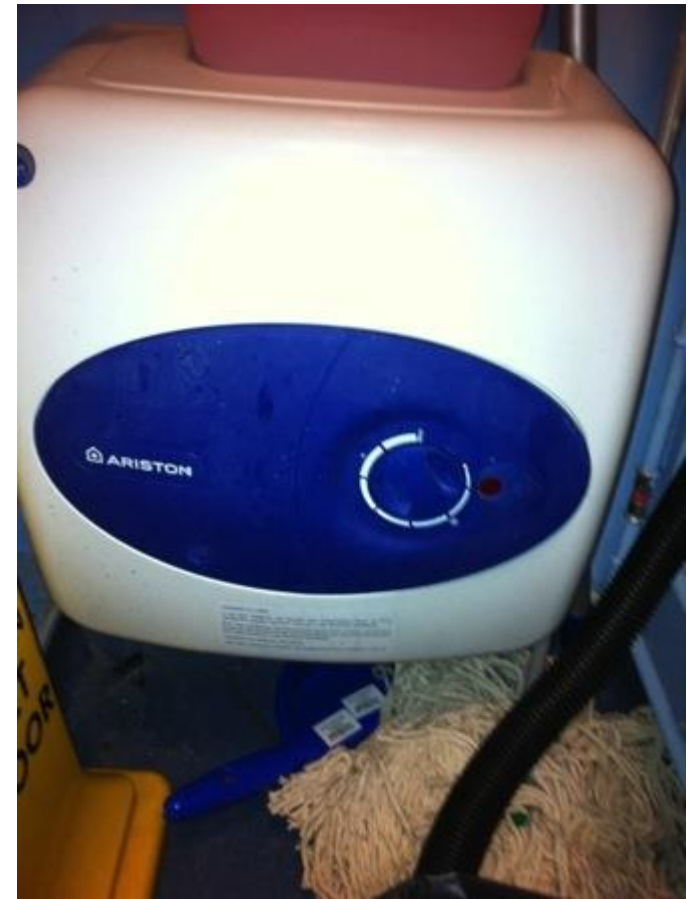
Distributed electric water heaters

- Zone 3 Hot Water – needs to be left on 24/7 for cleaners
- Some water heaters inaccessible so can't be controlled
