MERTHYR TYDFIL OLD TOWN HALL - A SYMBOL OF MERTHYR'S CIVIC PRIDE

MERTHYR TYDFIL OLD TOWN HALL - THE ARCHITECT'S ORIGINAL DRAWINGS

‘REDUCING THE CARBON FOOTPRINT OF A LISTED BUILDING’

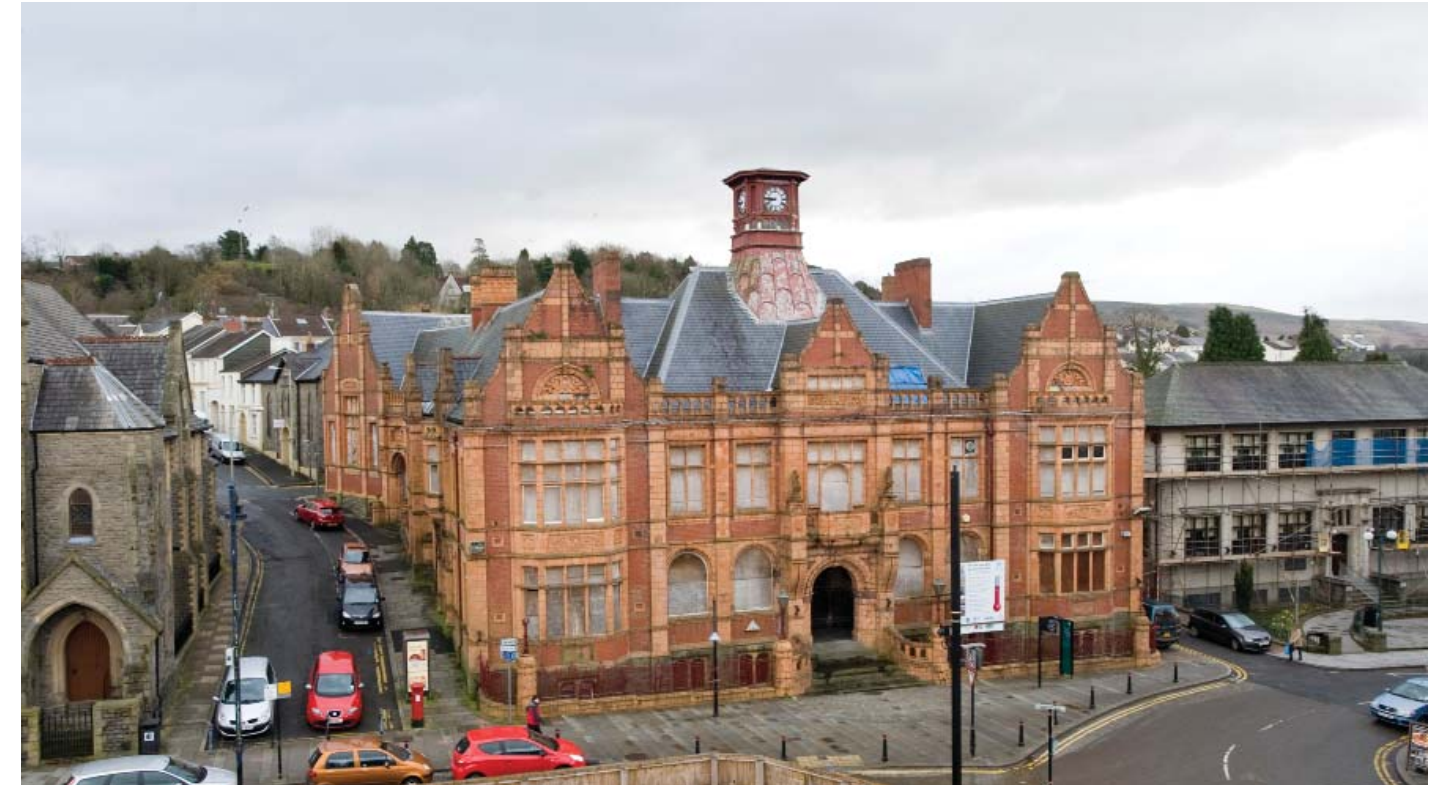
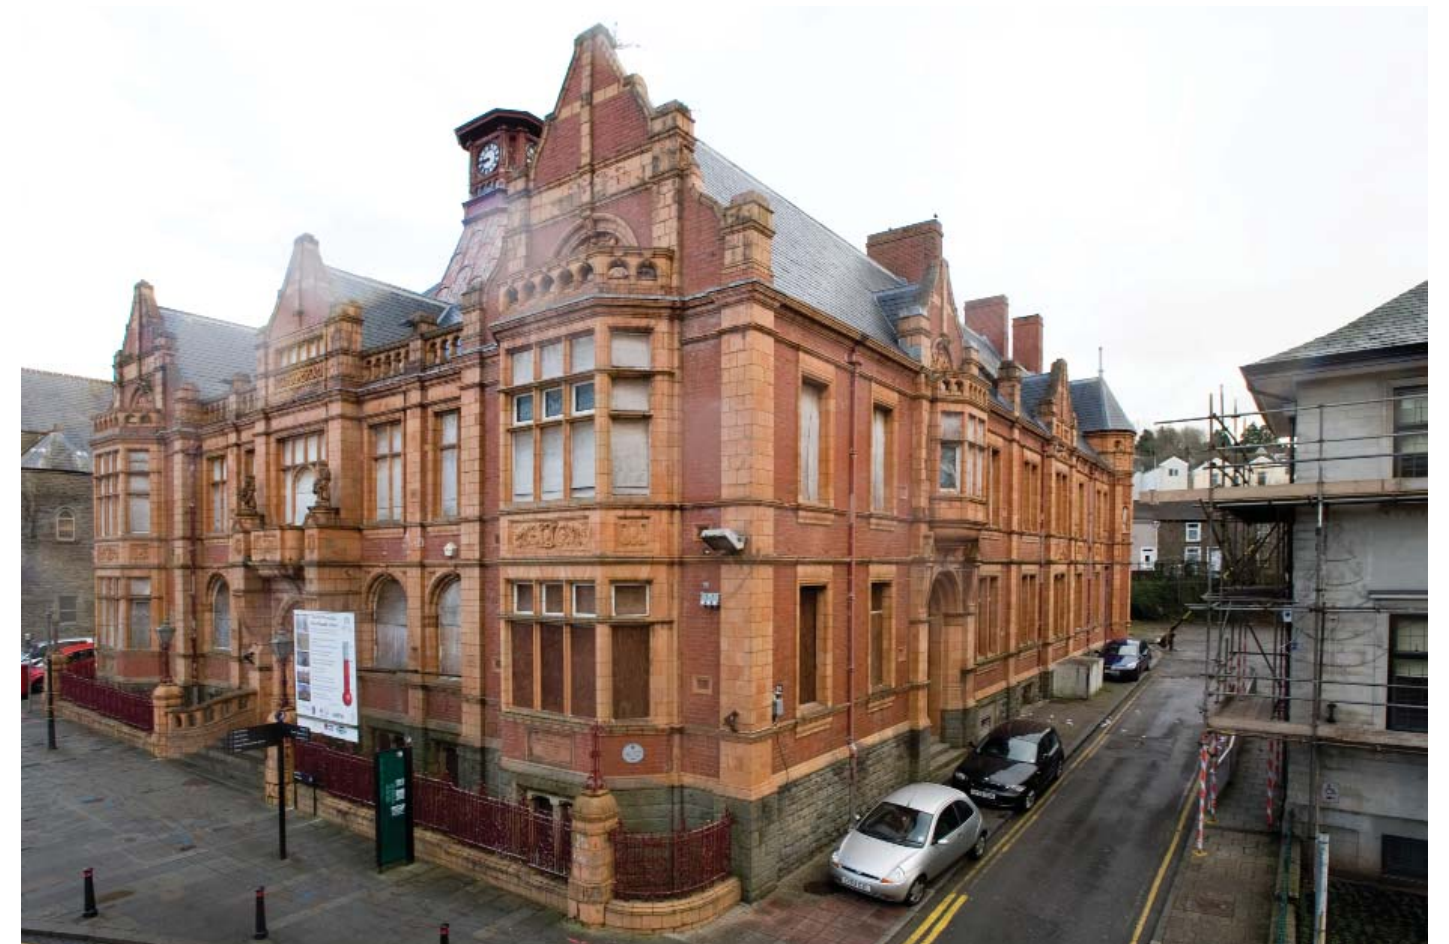
- Building re-use is ultimate in Sustainability;
- Making sure new uses are sustainable;
- Flexibility in use reduces risk of failure;
- Robust specification minimises maintenance;
- Working ‘with’ the building reduces carbon footprint & cost and maximises conservation;
- Investigation, assessment, sampling & testing to avoid unnecessary change;
- Reducing heat loss, but not breathability;
- Natural ventilation to most spaces;
- Emphasis on low energy services.

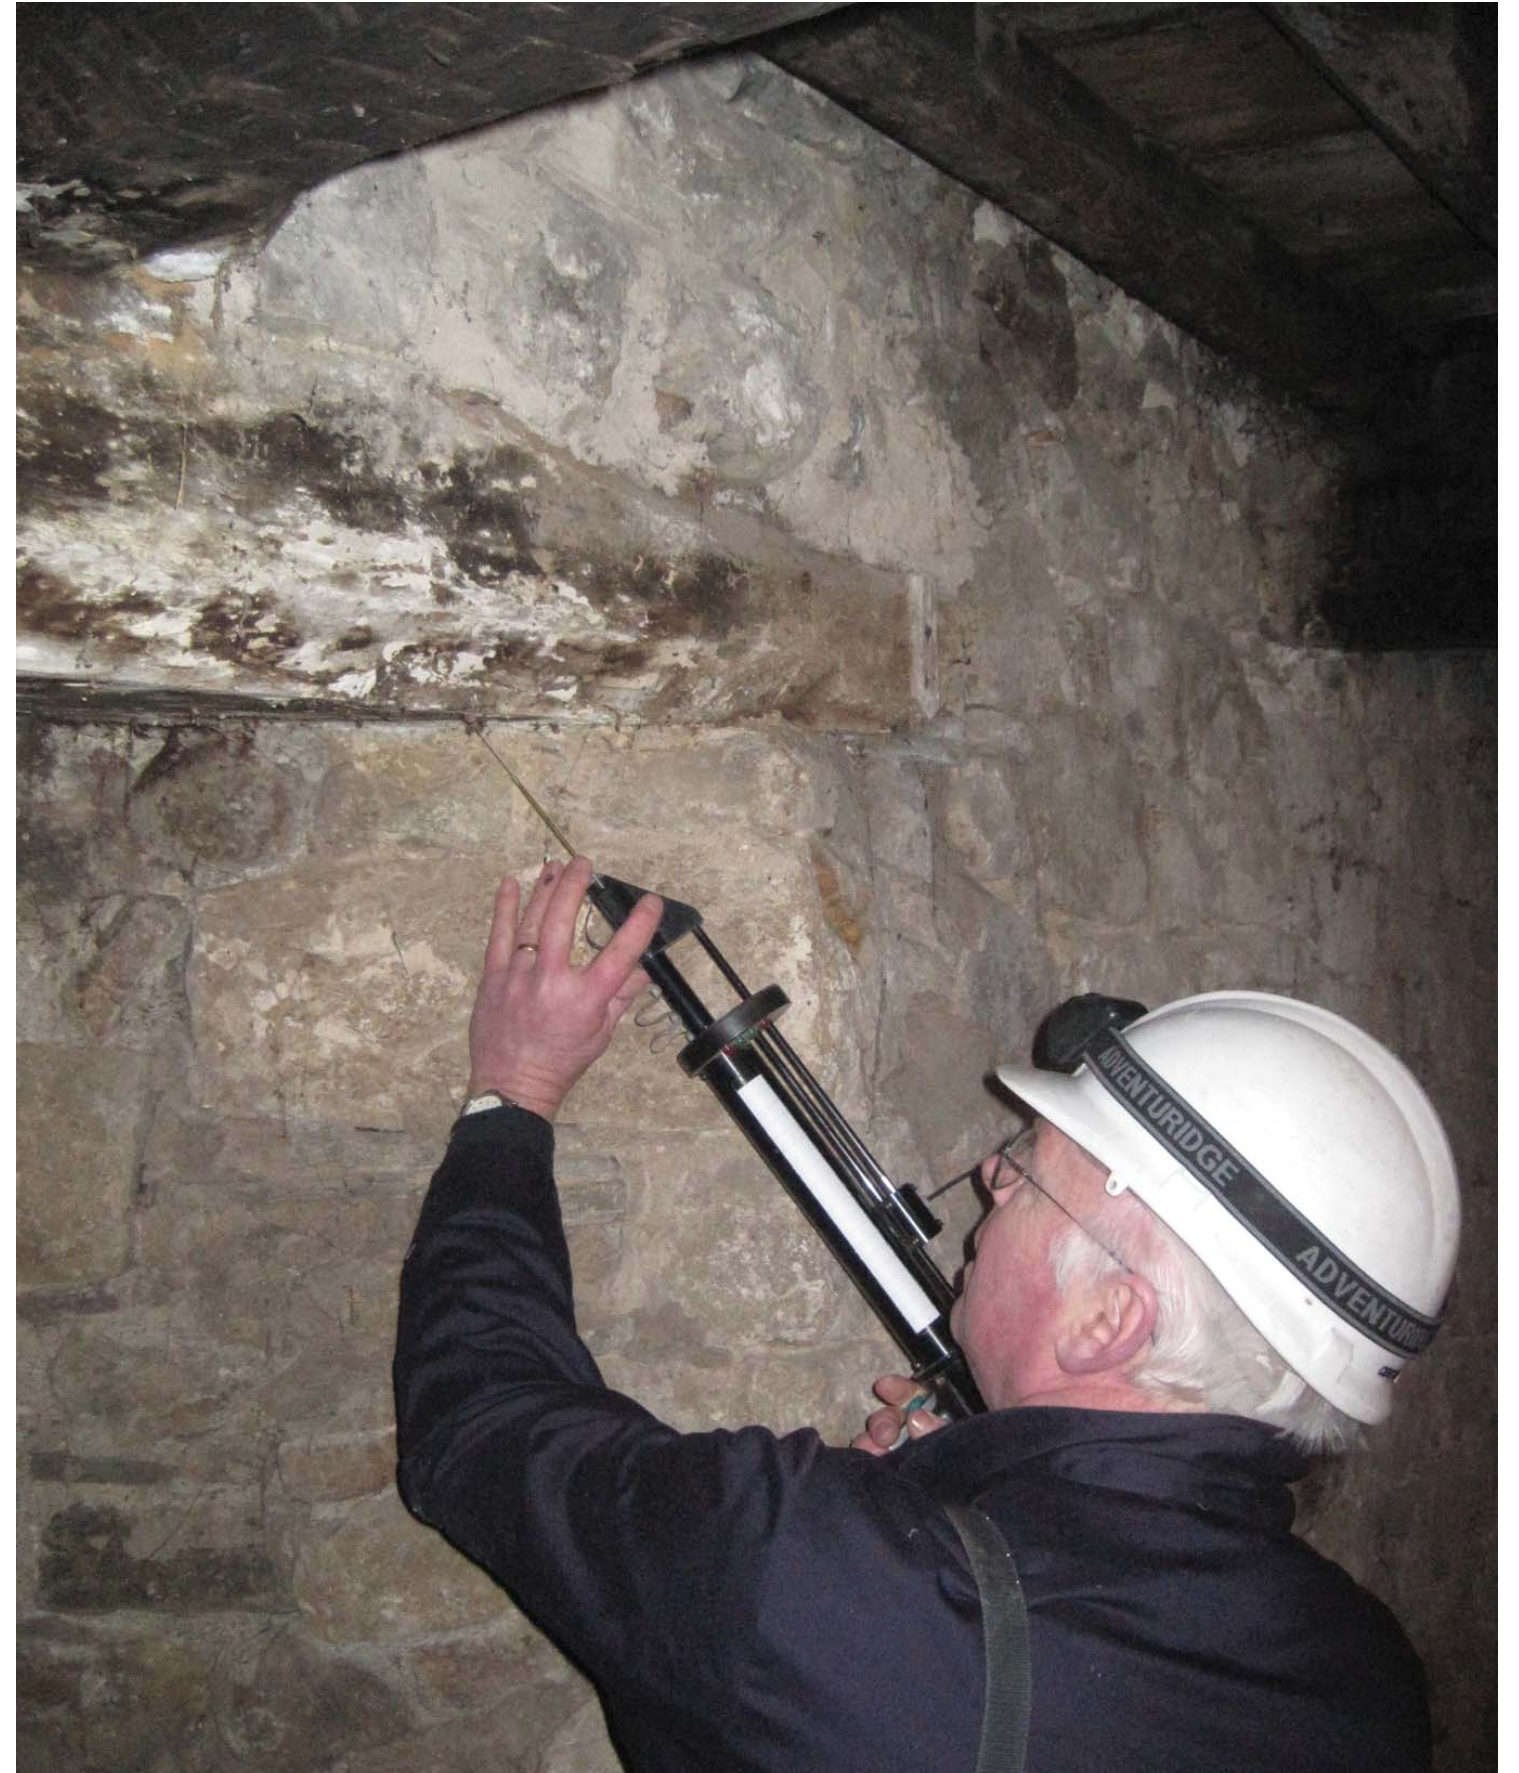
RETENTION OF EXISTING STRUCTURE - CONDITION

- Investigating the existing structures to permit their retention in the final scheme;
- Timber specialist investigation and report - only localised timber repairs required & recommendation for no chemical treatment.

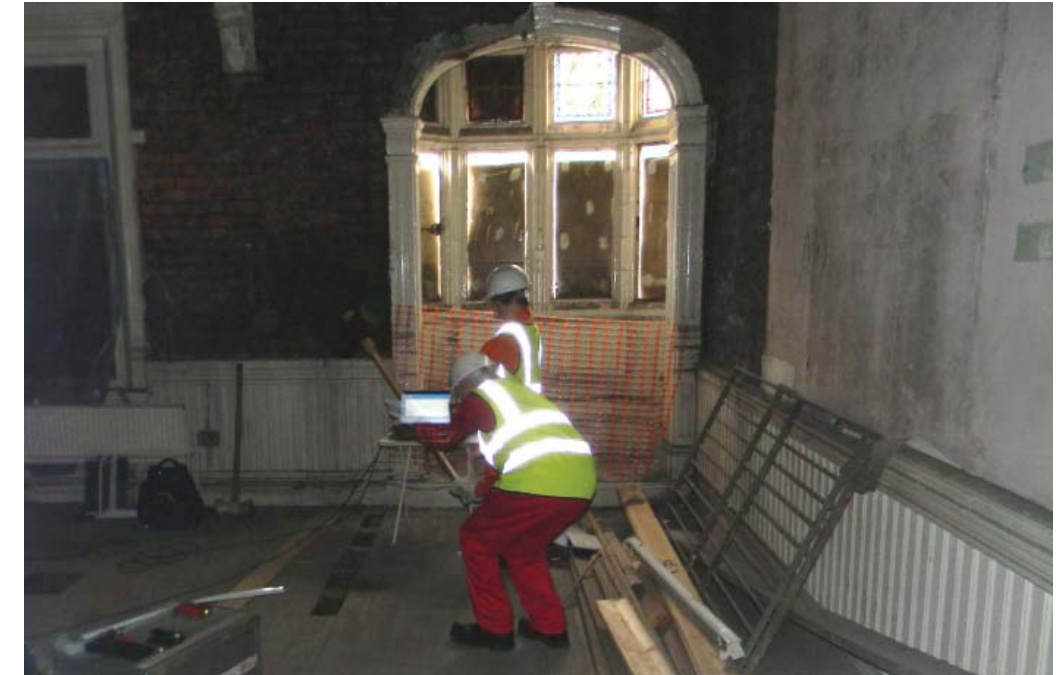
RETENTION OF EXISTING STRUCTURE - LOADING CAPACITY

- Opening up to allow measurement of all existing beams columns and joists, including drilling of cast iron columns to determine thickness;
- Calculation of each floor capacity in its original condition and production of 'loading drawings'. Majority of floors comply with current design standards for proposed uses;
- Dynamic testing of the floor to use for dance studio to prove suitability of the floor for this use.

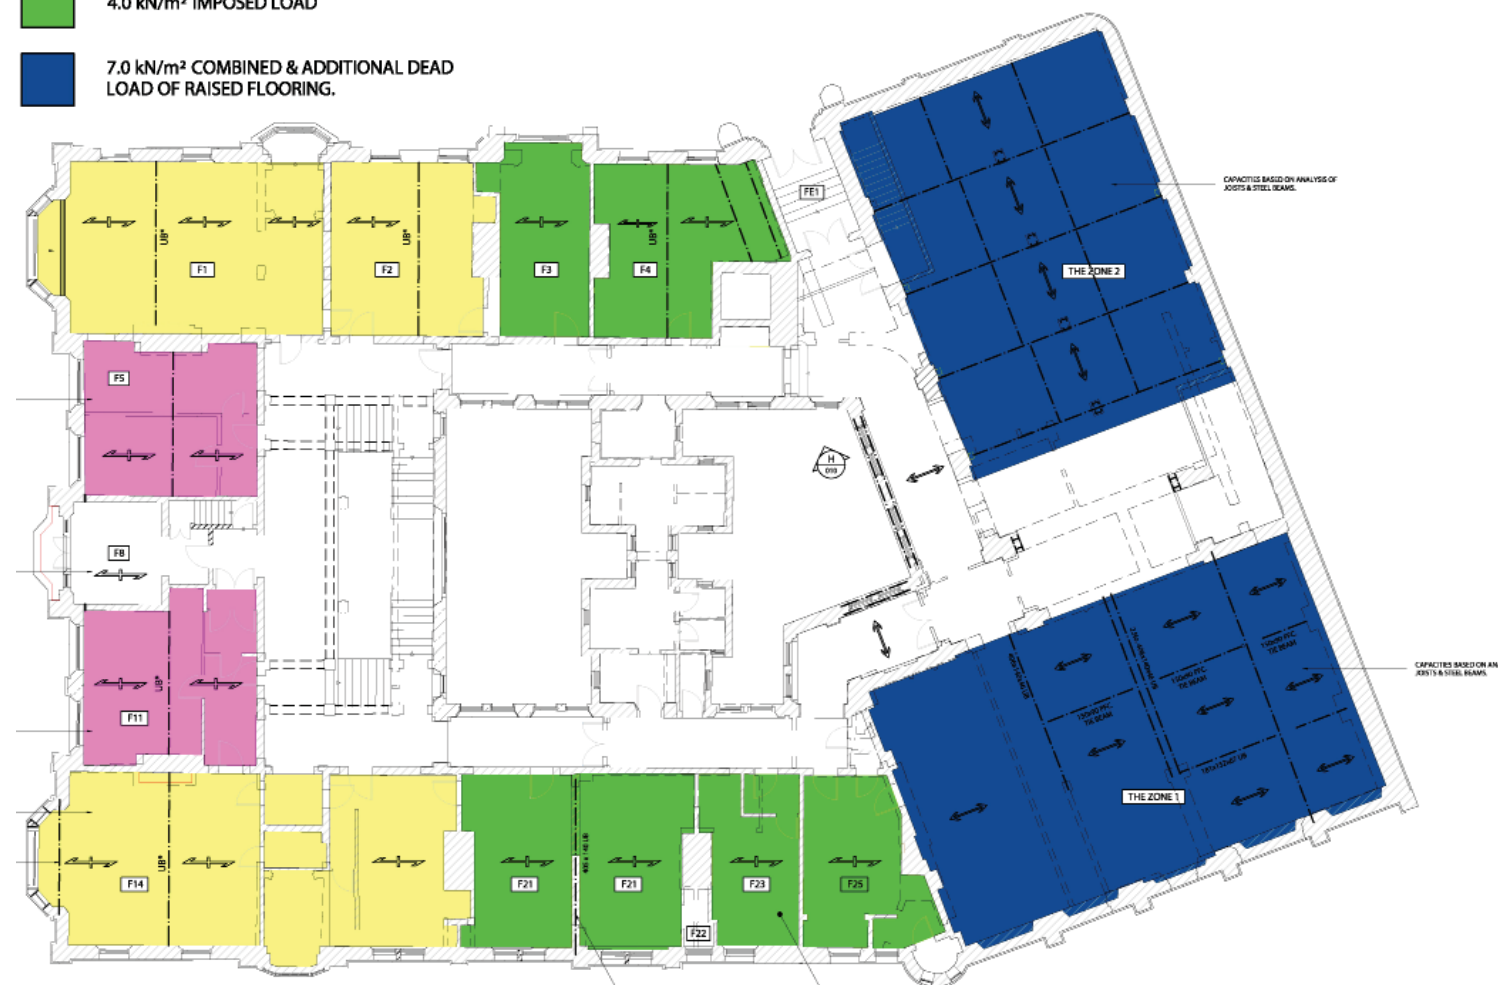
KEY - ALLOWABLE FLOOR LOADING

- 2.0 kN/m² IMPOSED LOAD
- 3.5 kN/m² IMPOSED LOAD
- 4.0 kN/m² IMPOSED LOAD
- 7.0 kN/m² COMBINED & ADDITIONAL DEAD LOAD OF RAISED FLOORING.

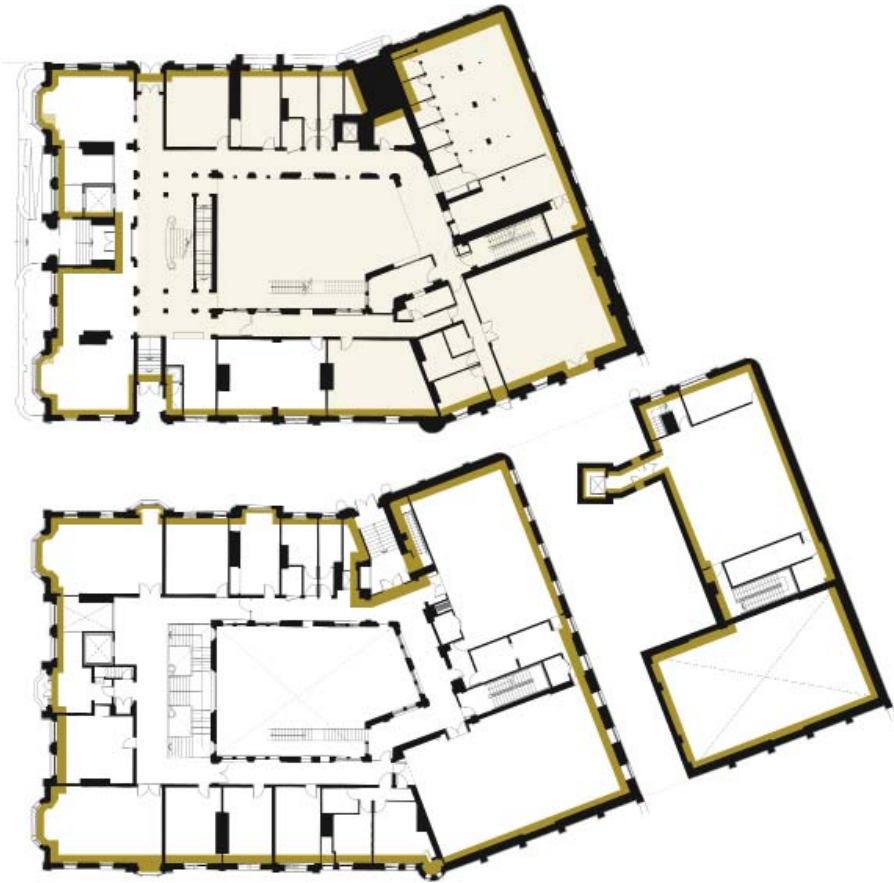
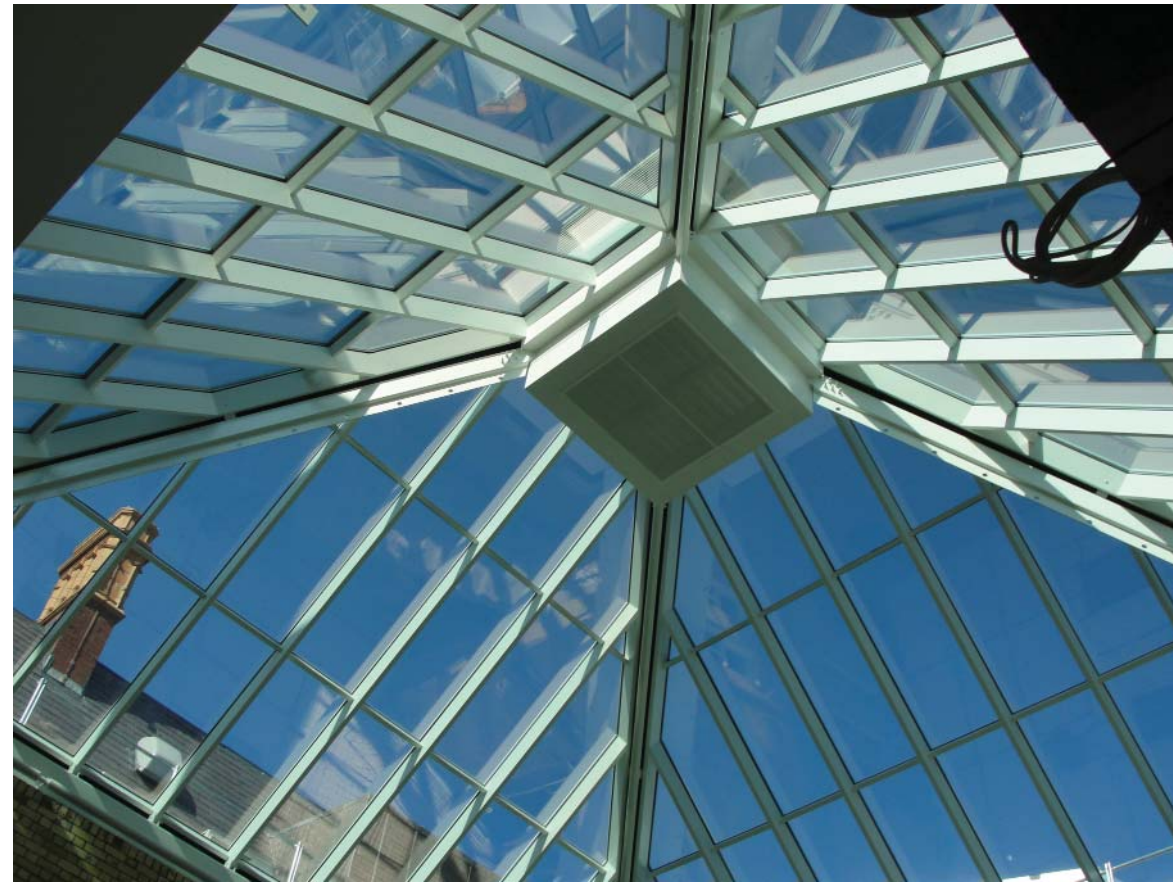
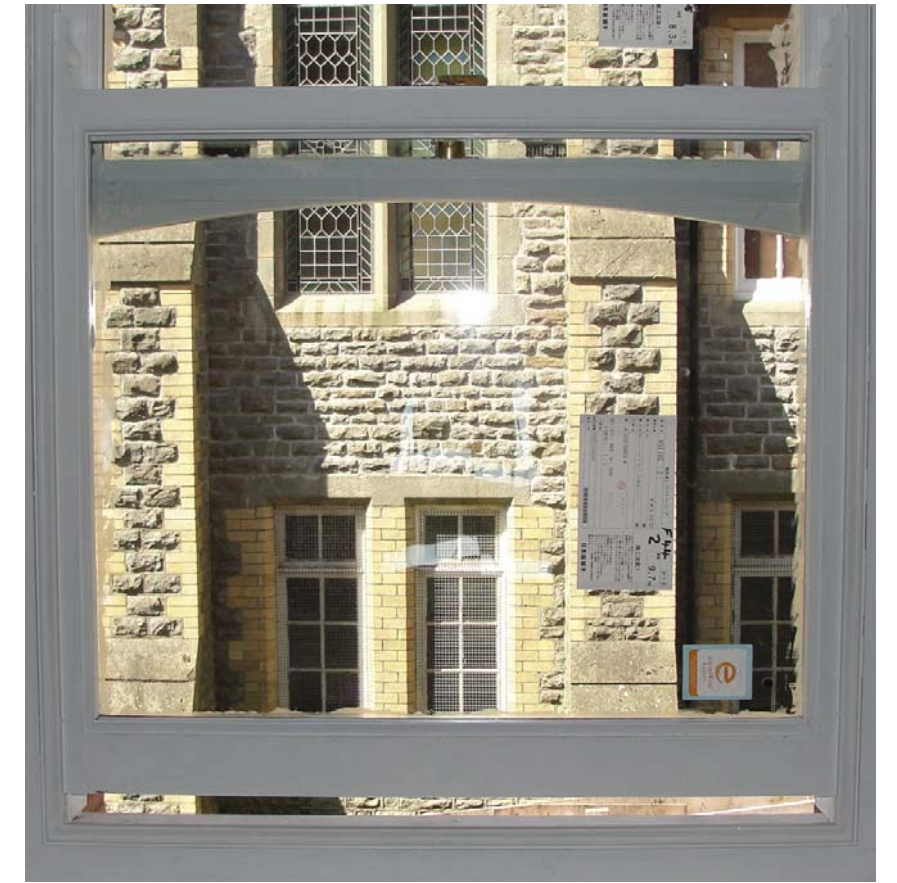
HOW COULD WE BEST REDUCE ENERGY USE WHILST SENSITIVELY CONSERVING?

- Reduce external wall area by 25%;
- Insulate the inside face of the external walls with 'breathable' construction;
- Natural ventilation to almost all spaces, including central courtyard;
- Insert thin double glazing units into single glazed windows;
- Emphasis on low energy services - modelled to reduce carbon footprint.

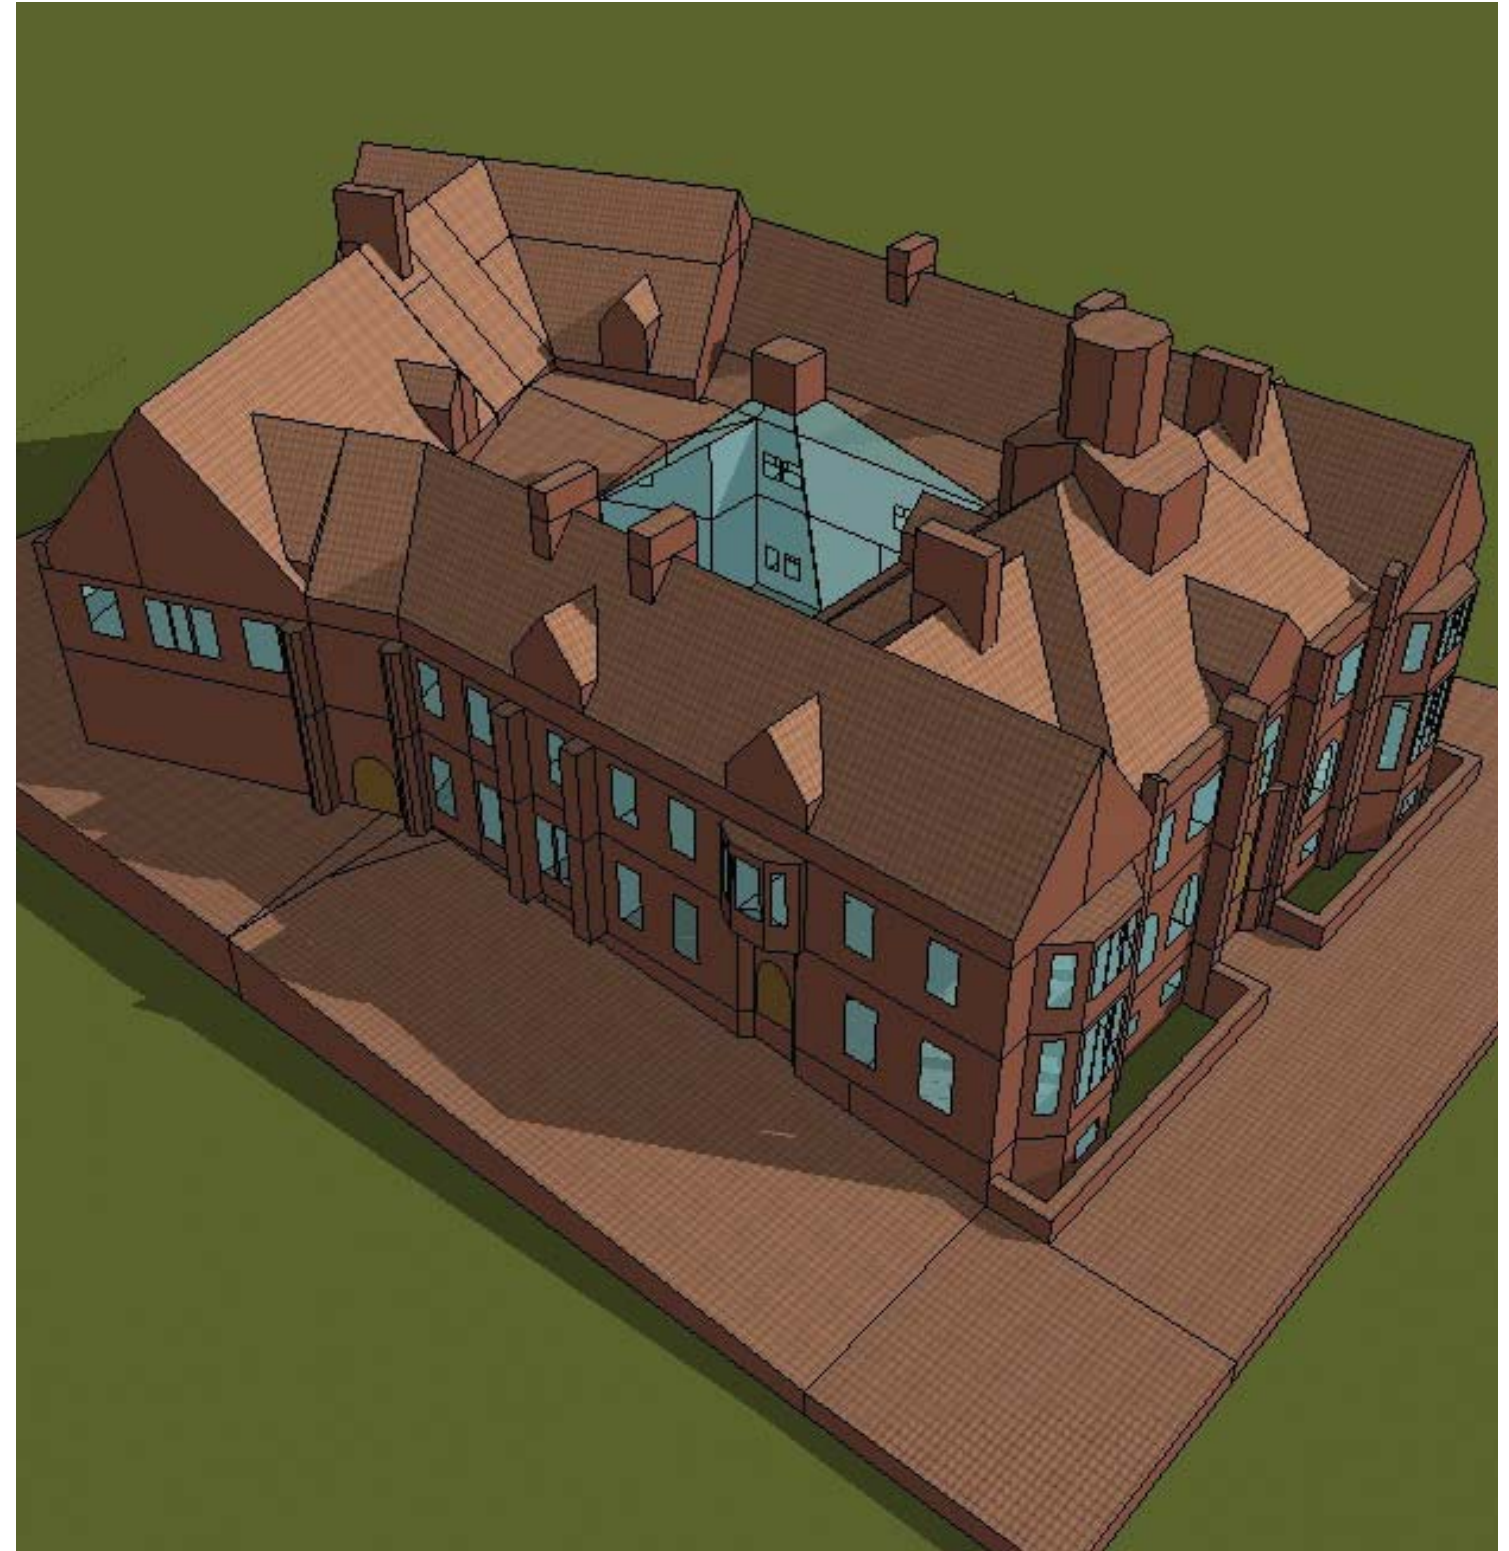
- Servicing complex M&E requirements within grade 2* listed building;
- Minimising Energy consumption whilst retaining original character & fabric;
- Sensitive acoustic issues within recording studios;
- Dealing with significant heat gains where little or no scope for natural ventilation;
- Aesthetically challenging selection of luminaires;
- Limited space for services installation.

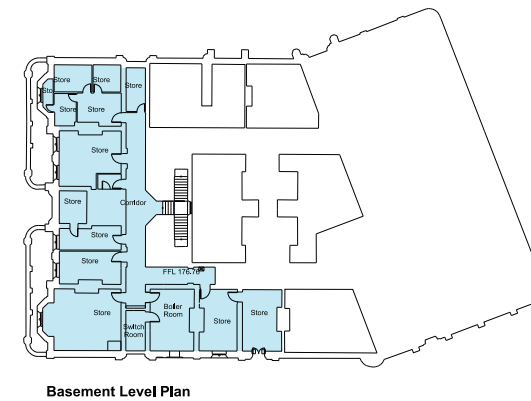
Basement Level Plan

- Fully accessible entrances, where possible;
- Level flooring on each of the four floors;
- Lift access to all spaces on all levels;
- Clear and concise signage.
