Building Better Buildings

22nd March 2016

Building Performance Evaluation: In-use Post Occupancy Evaluation – a Welsh Case Study

Building Performance Evaluation

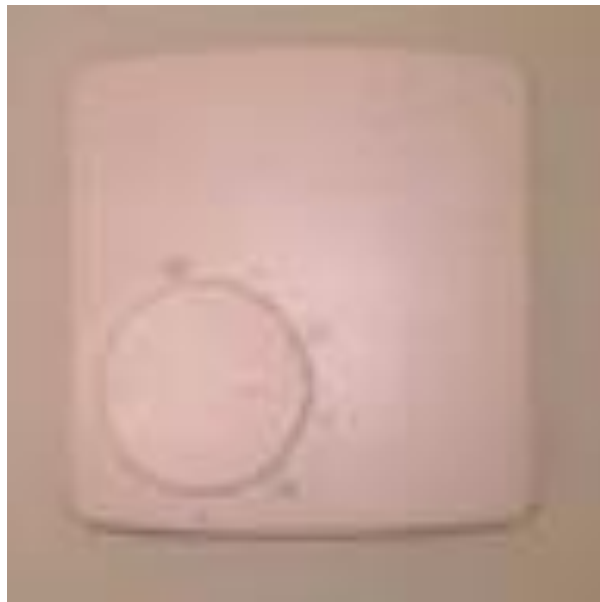
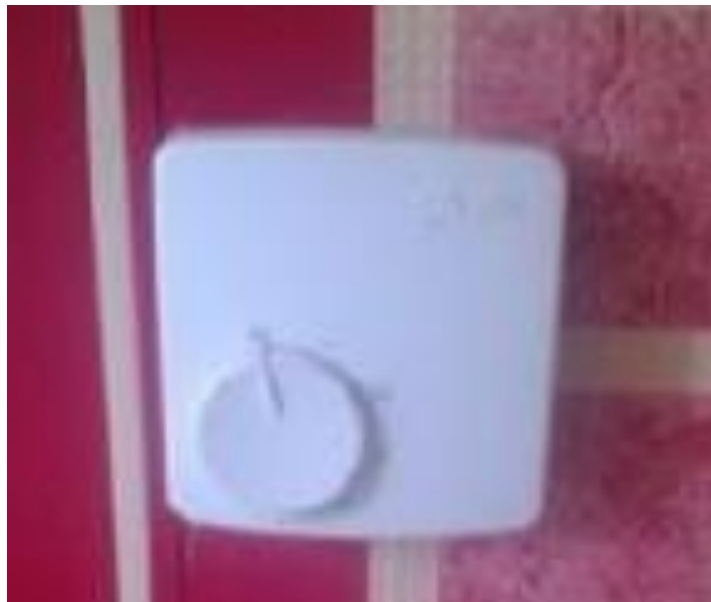
Both dwellings are similar as far as the local room controls are concerned. The thermostats in House . were set to maximum (30°C),

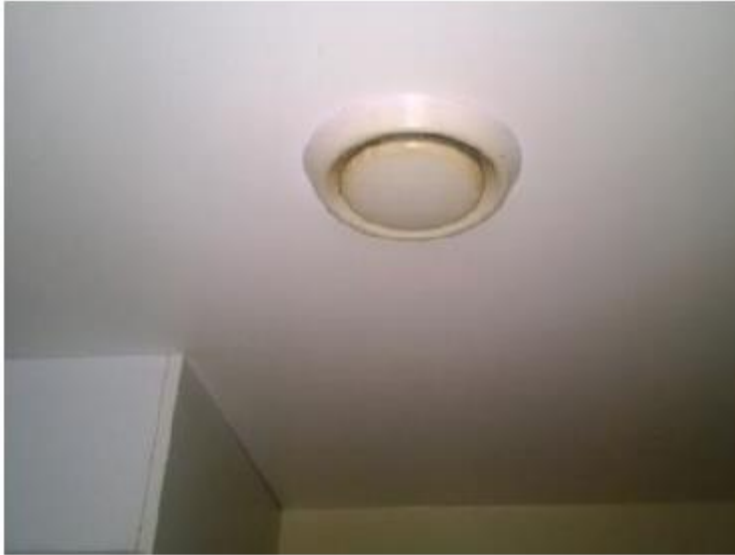
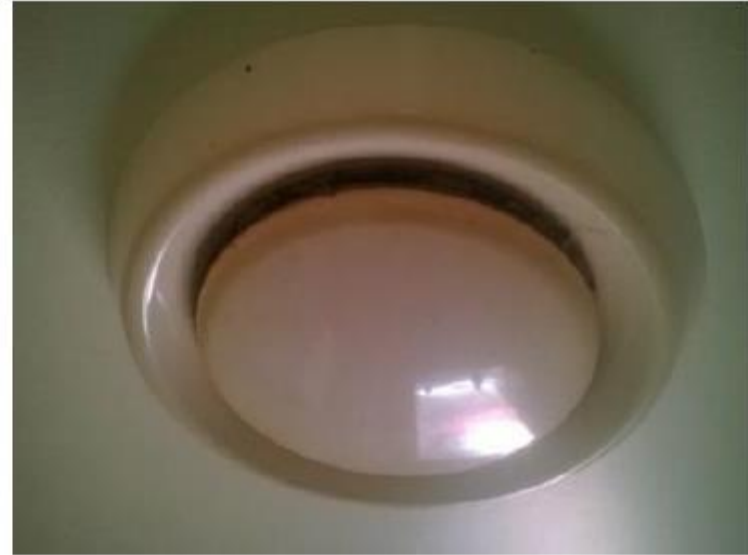
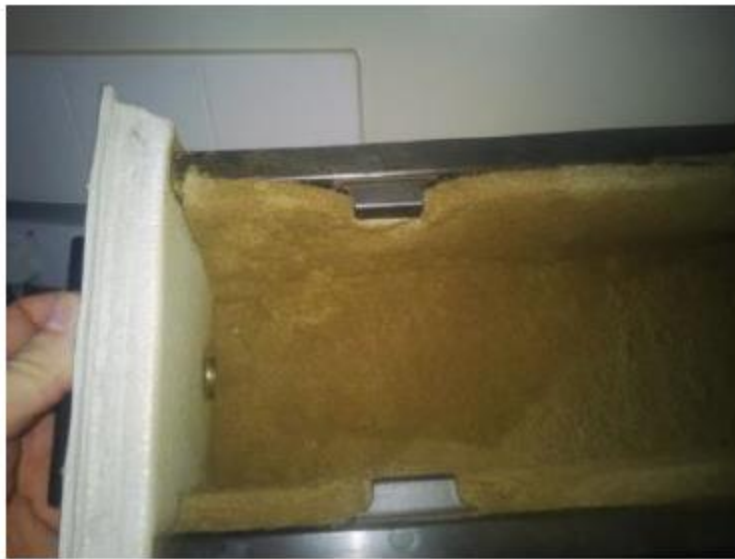
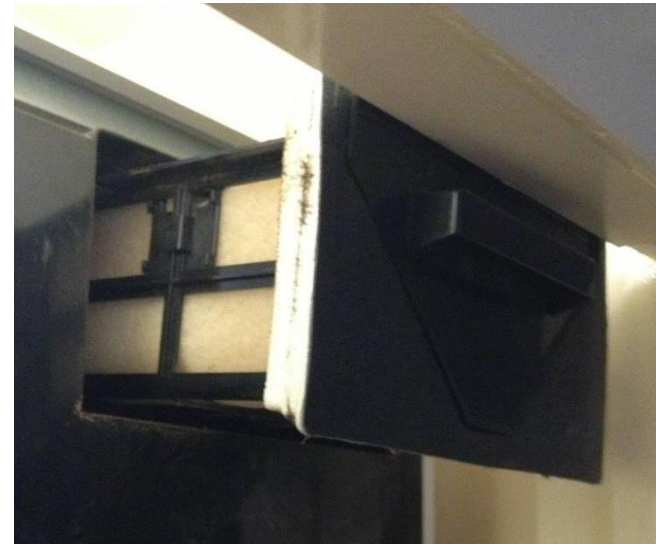
Occupant interaction with extract ventilation & filters

- Ceiling terminals for extracting air from some rooms: inspected as altered and also dust, grease and particulate matter was found to be blocking the ducting, both.

- Both house and flat: occupants 'fail' to understand the 'nuances of the installed EASHPs/under-floor heating, operated as 'turn-on/off' & timed – even after repeated instructions during handover, and the BPE project. Filter cleaning problem.

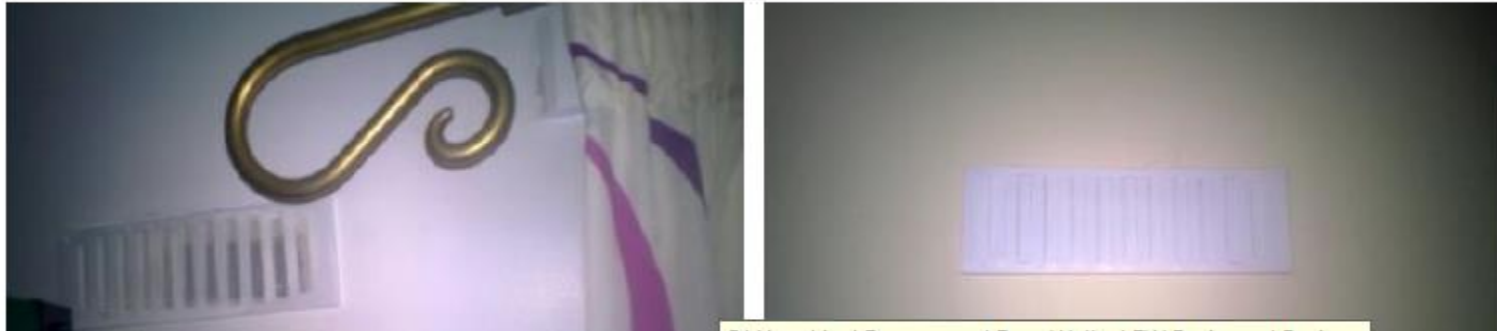
Occupant interaction with supply ventilation

Air make-up (to replace the air extracted by the NIBE system) is via wall transfer grilles in each property. These are located in each of the non-wet rooms, i.e. living rooms and bedrooms. This type of air inlet and the installed capacity is appropriate for this type of ventilation system. As often found, however, is the tendency for occupants to close these (Figure 2.6), either due to perceived heat loss, or discomfort from draughts, or both. Two out of the three air inlets in House 4 were found to be closed, and two out of two air inlets in Flat 6A were found to be closed. This finding is symptomatic of poor user guidance and understanding and it is recommended that guidance is made available as detailed earlier in this report.

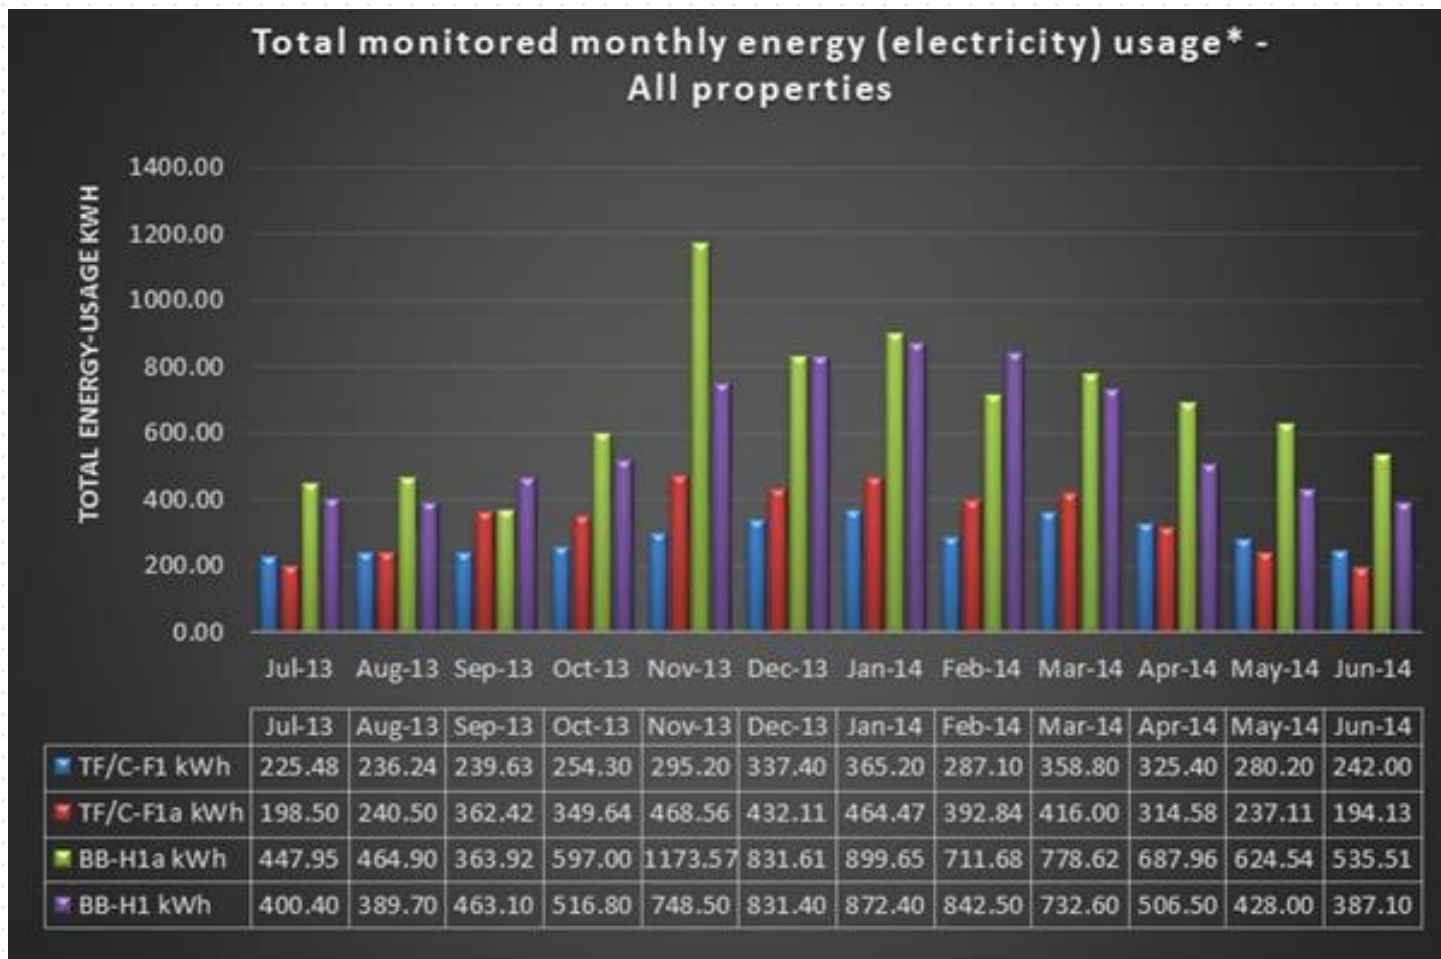
Occupancy patterns are linked to higher energy usage as are greater exposed facades

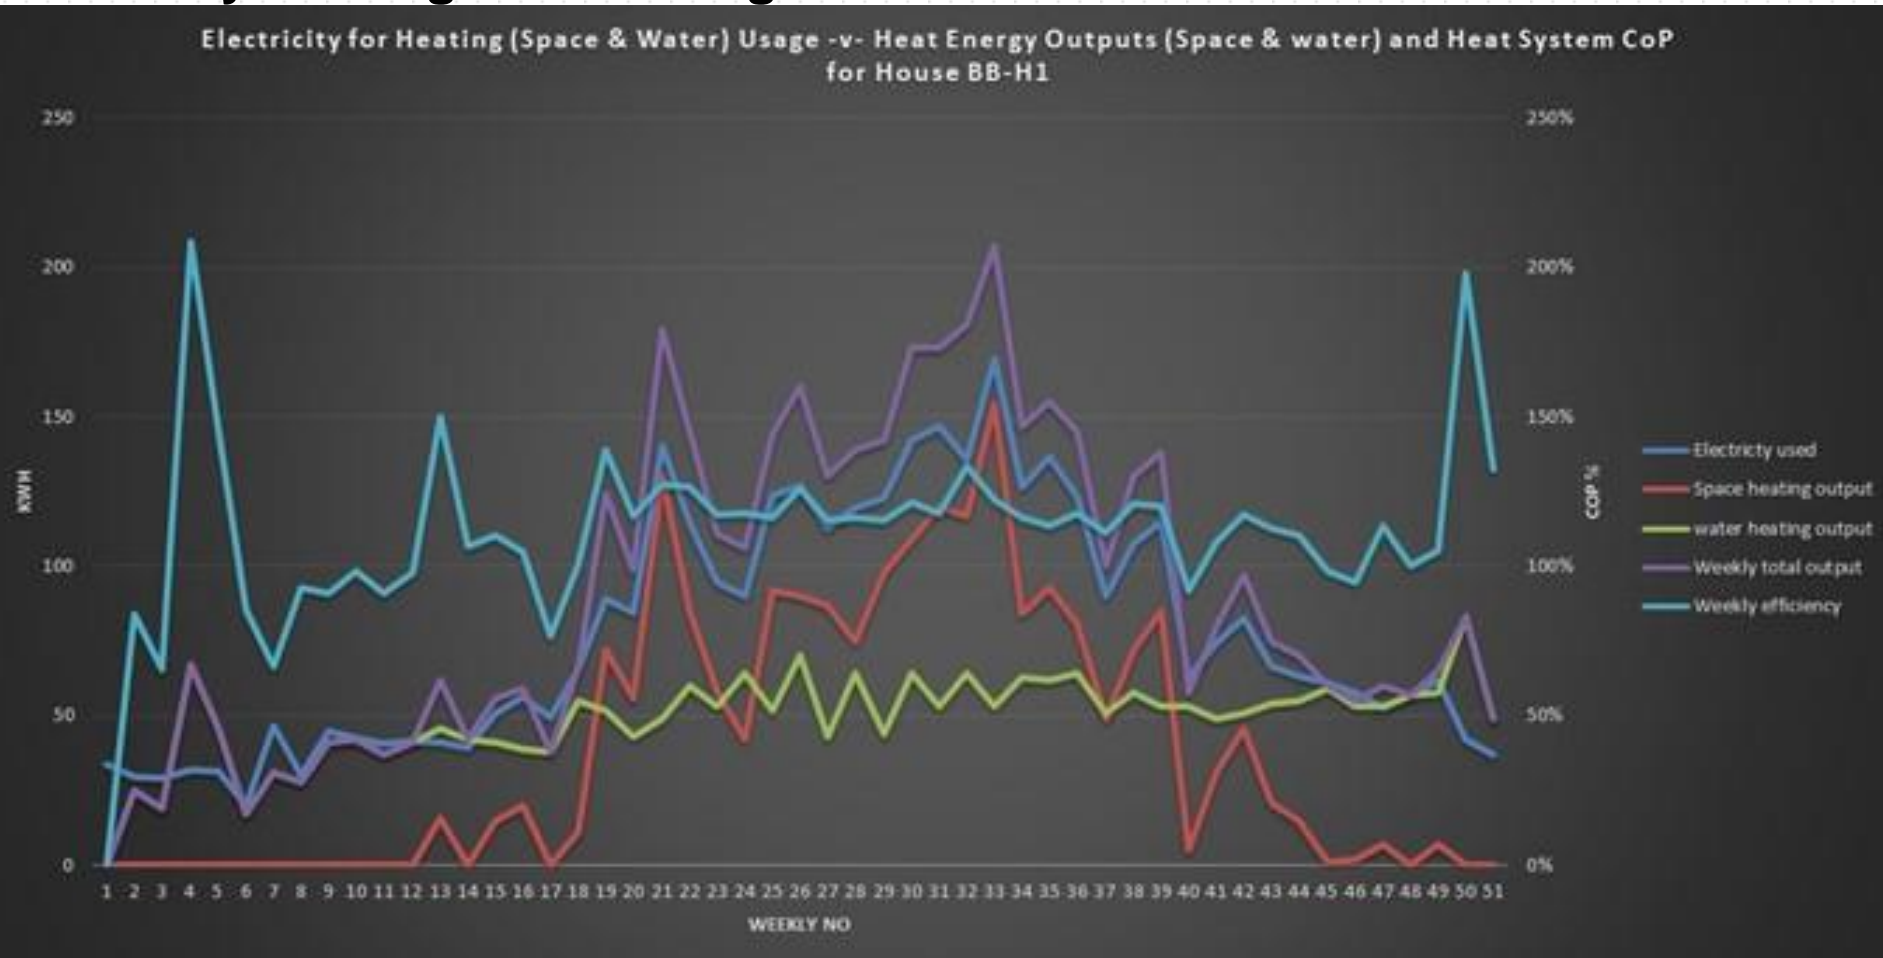
The Derived CoP values are unusual. Notable, the maximum Derived CoPs occur in the SAP non-heating period; July to September, before the first heating period begins.

NIBE SYSTEM	NIBE-Published CoP	Derived CoP Maximum (Difference)	Derived CoP Minimum (Difference)
Fighter 360P	3.40	2.09 (-1.31)	0.655 (-2.75)

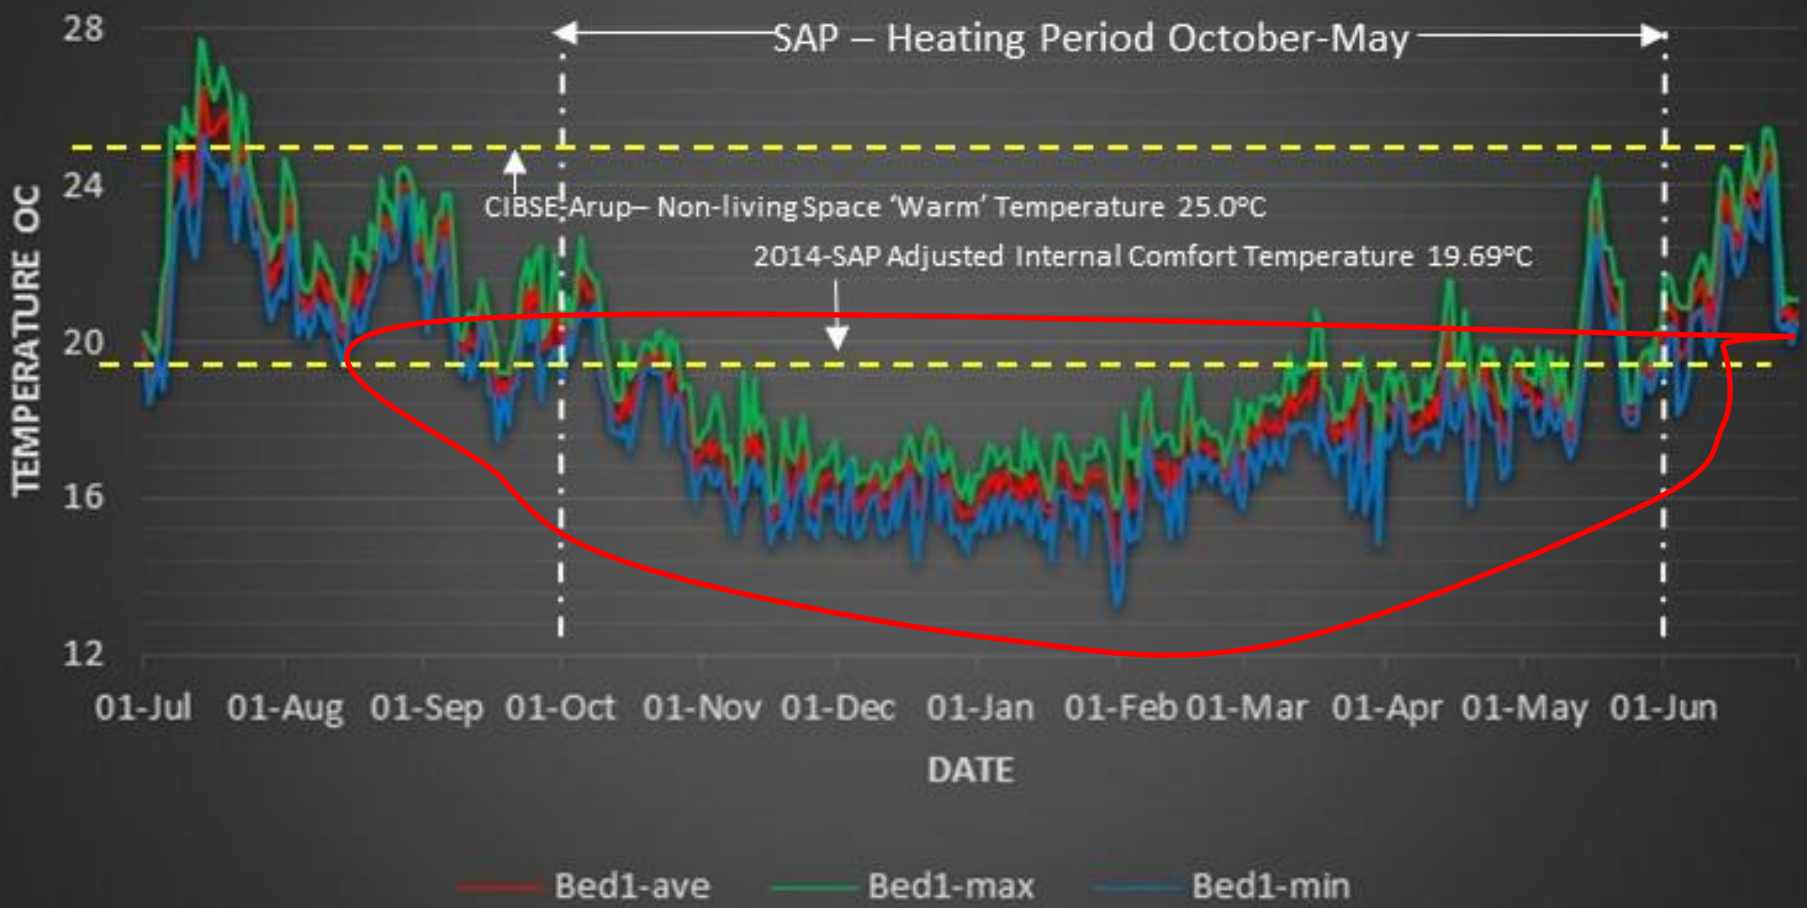
Internal Monitored Daily Non-living-space (Bedroom-1 [East-facing]) Temperatures for BB-H1

Underheating/Overheating - cause may not be the M&E, occupants could be the fabric

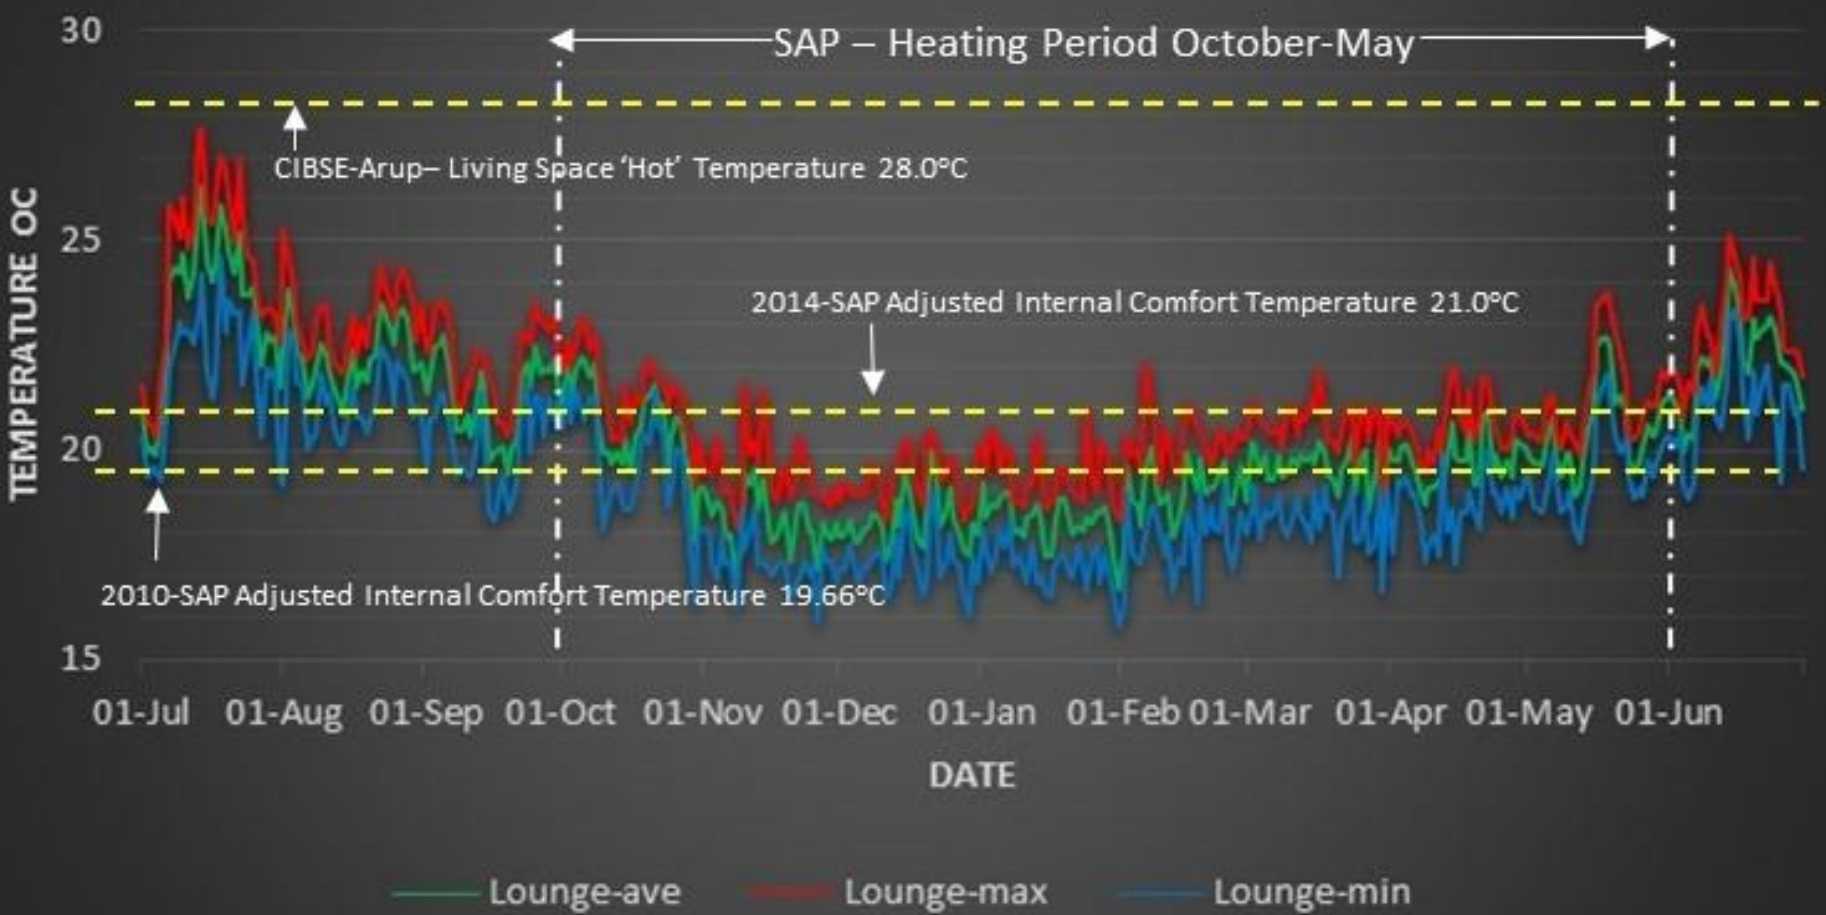
Internal Monitored Daily Living-space (Lounge) Temperatures for BB-H1

Underheating/Overheating - cause may not be the M&E, occupants could be the fabric

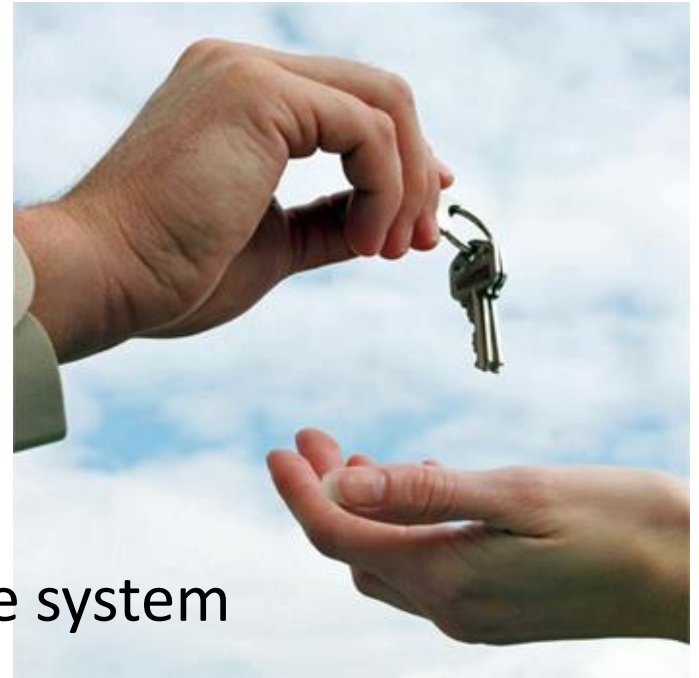
Handover

- Training (DVD)
- Documentation (BREEAM points)
- Defects:
 - Door security
 - Heating pipes (plant room)
 - Mikrofill – pressure maintenance system
 - Water boilers
 - Meters
 - Cracks

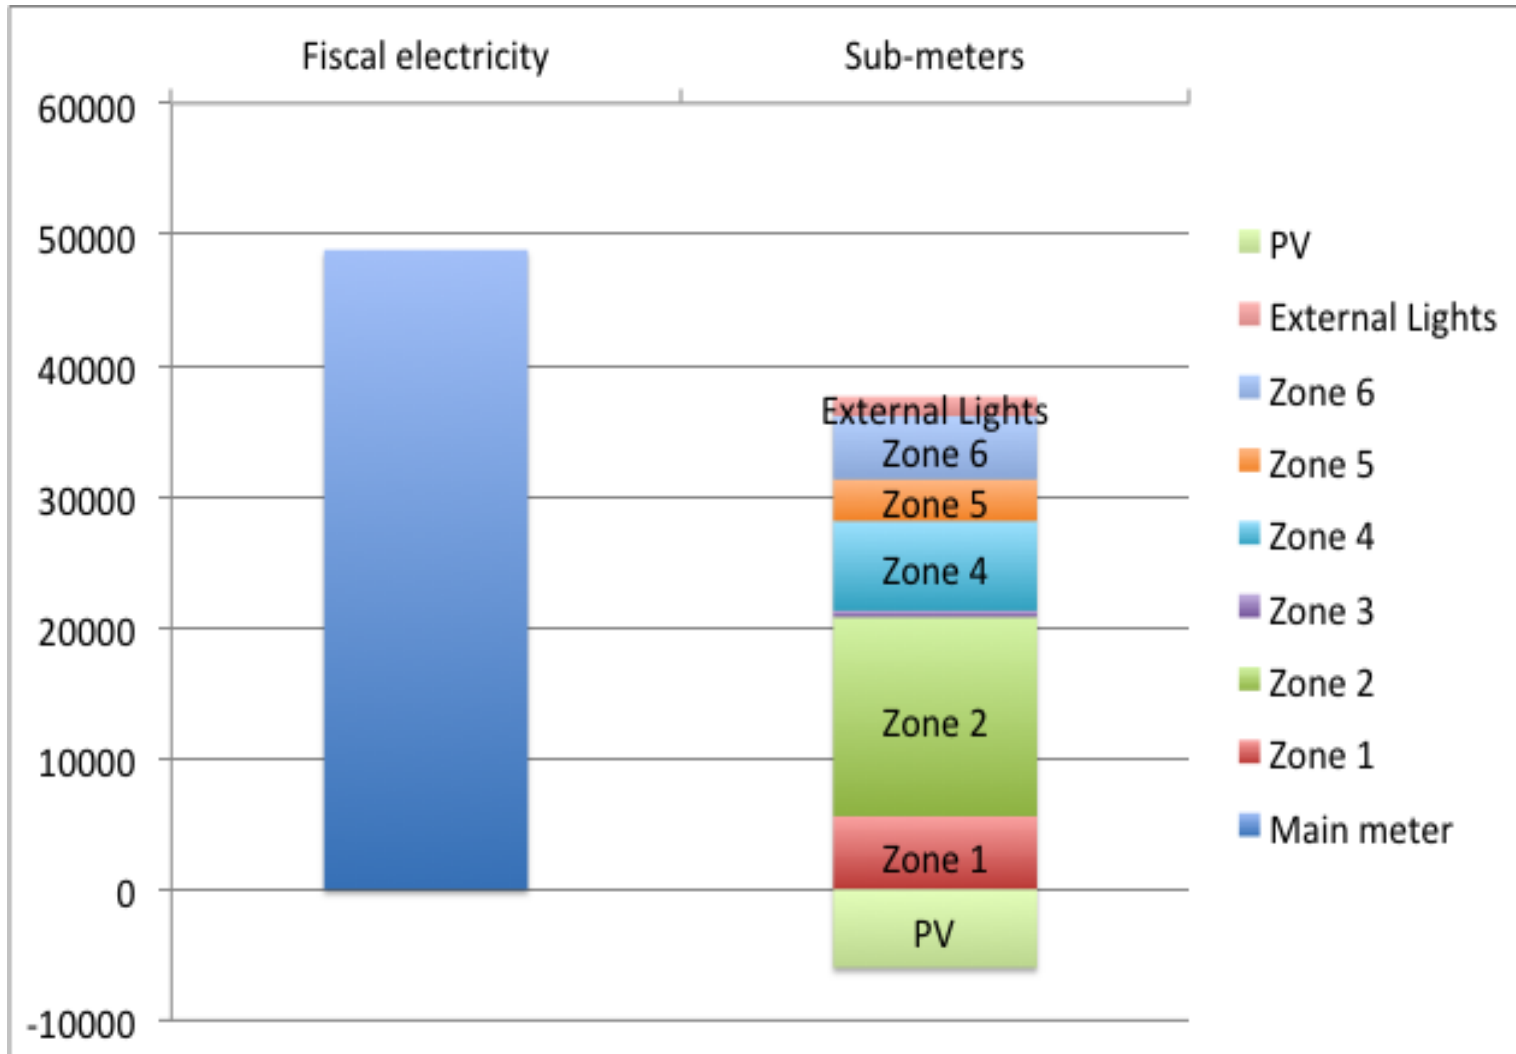
Electricity Metering - Reconciliation

77%
electricity
usage
accounted
for:
Plant room,
pumps, fans
and controls
not sub-
metered

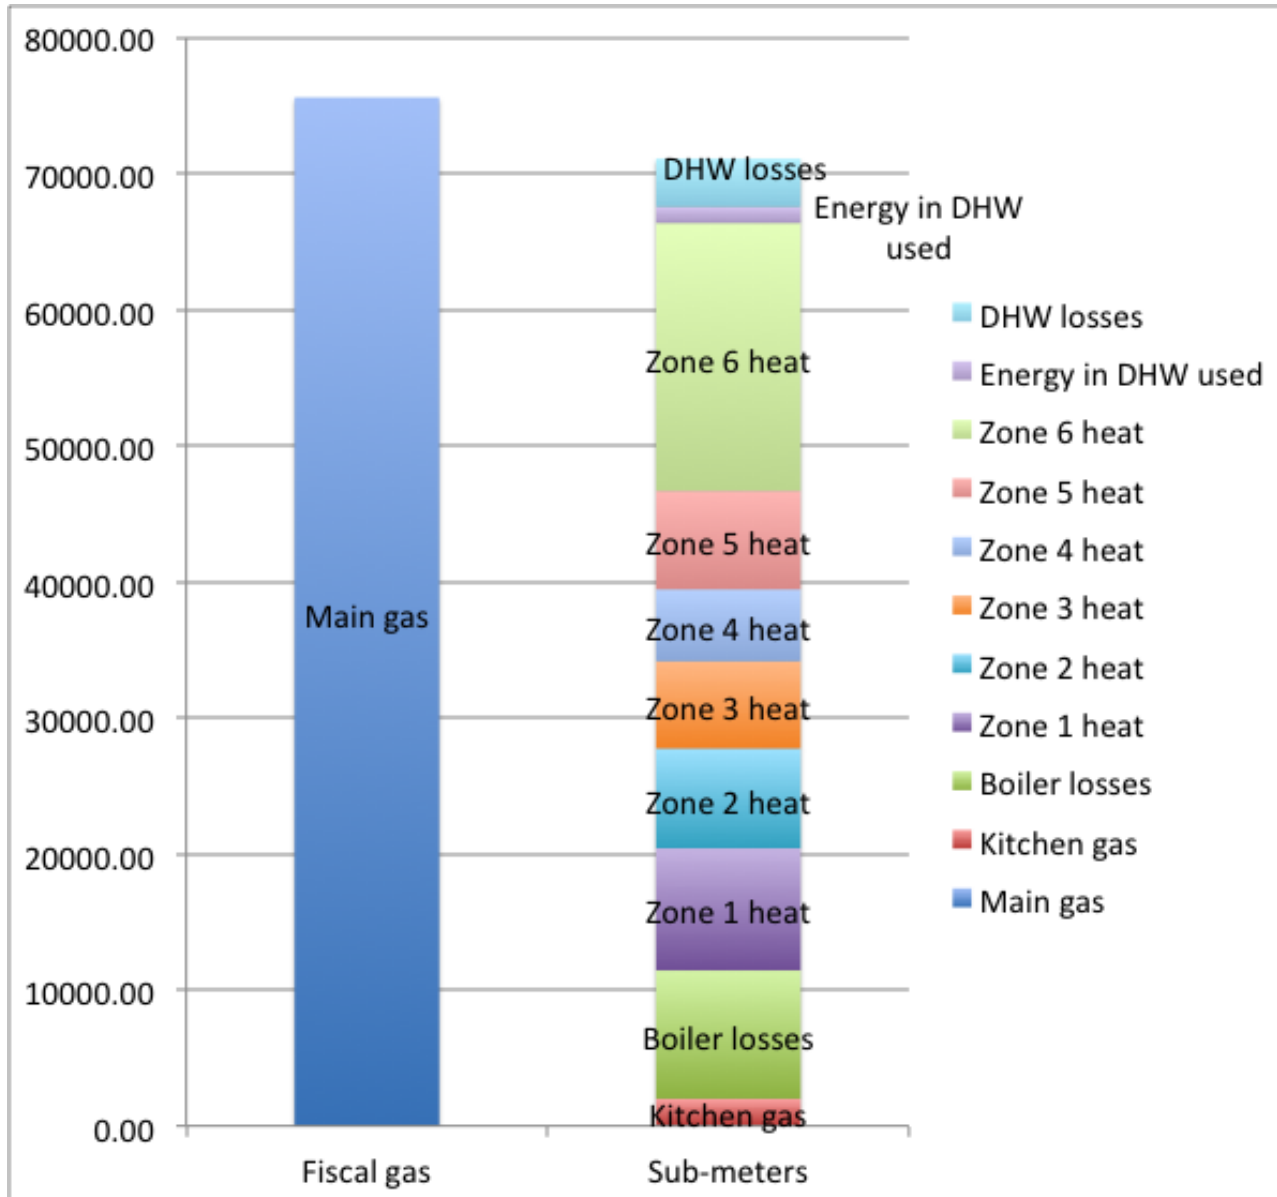
Gas/Heat Metering - Reconciliation

92% of gas energy accounted for

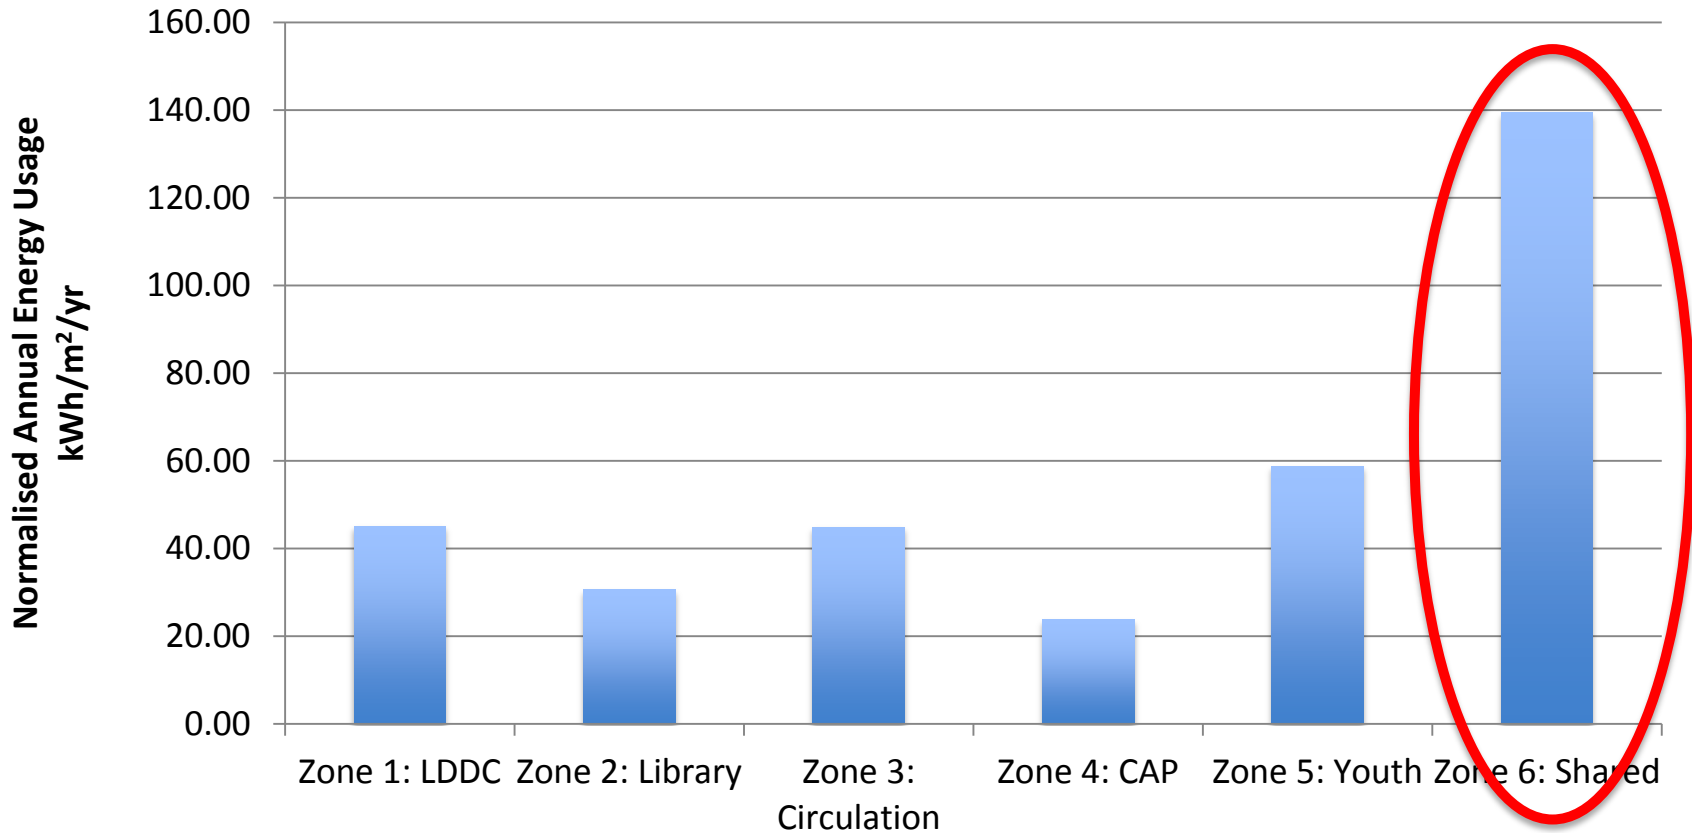
~£1500/yr to heat the hall

~£500/yr youth heating

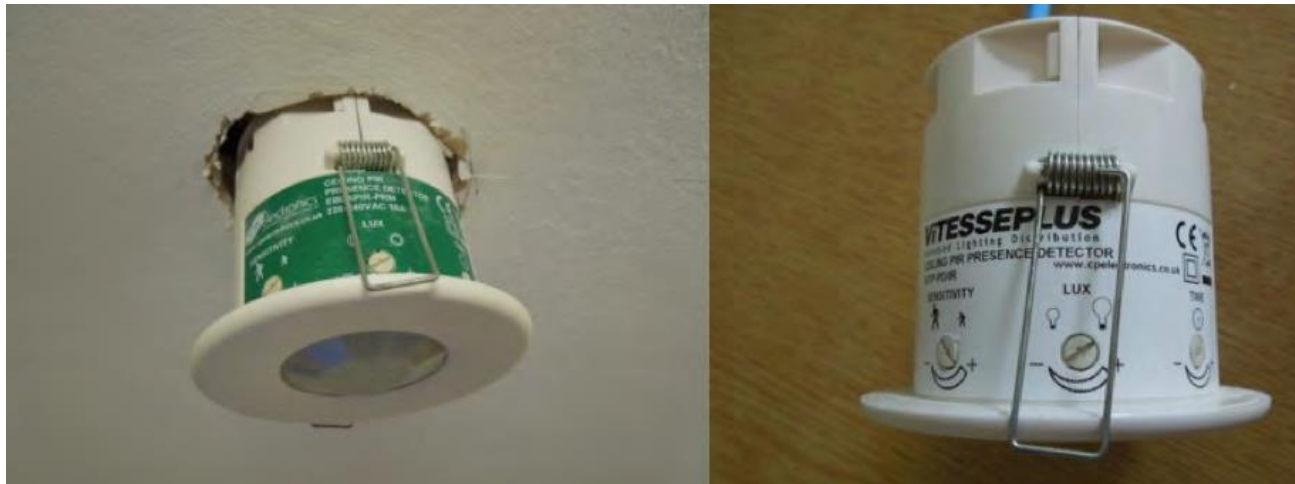
Lighting

- Youth and CAP offices
- Hall cupboards, gallery, youth activity area – PIR adjustments (£8/yr)
- Youth ‘lounge’ (resolved)

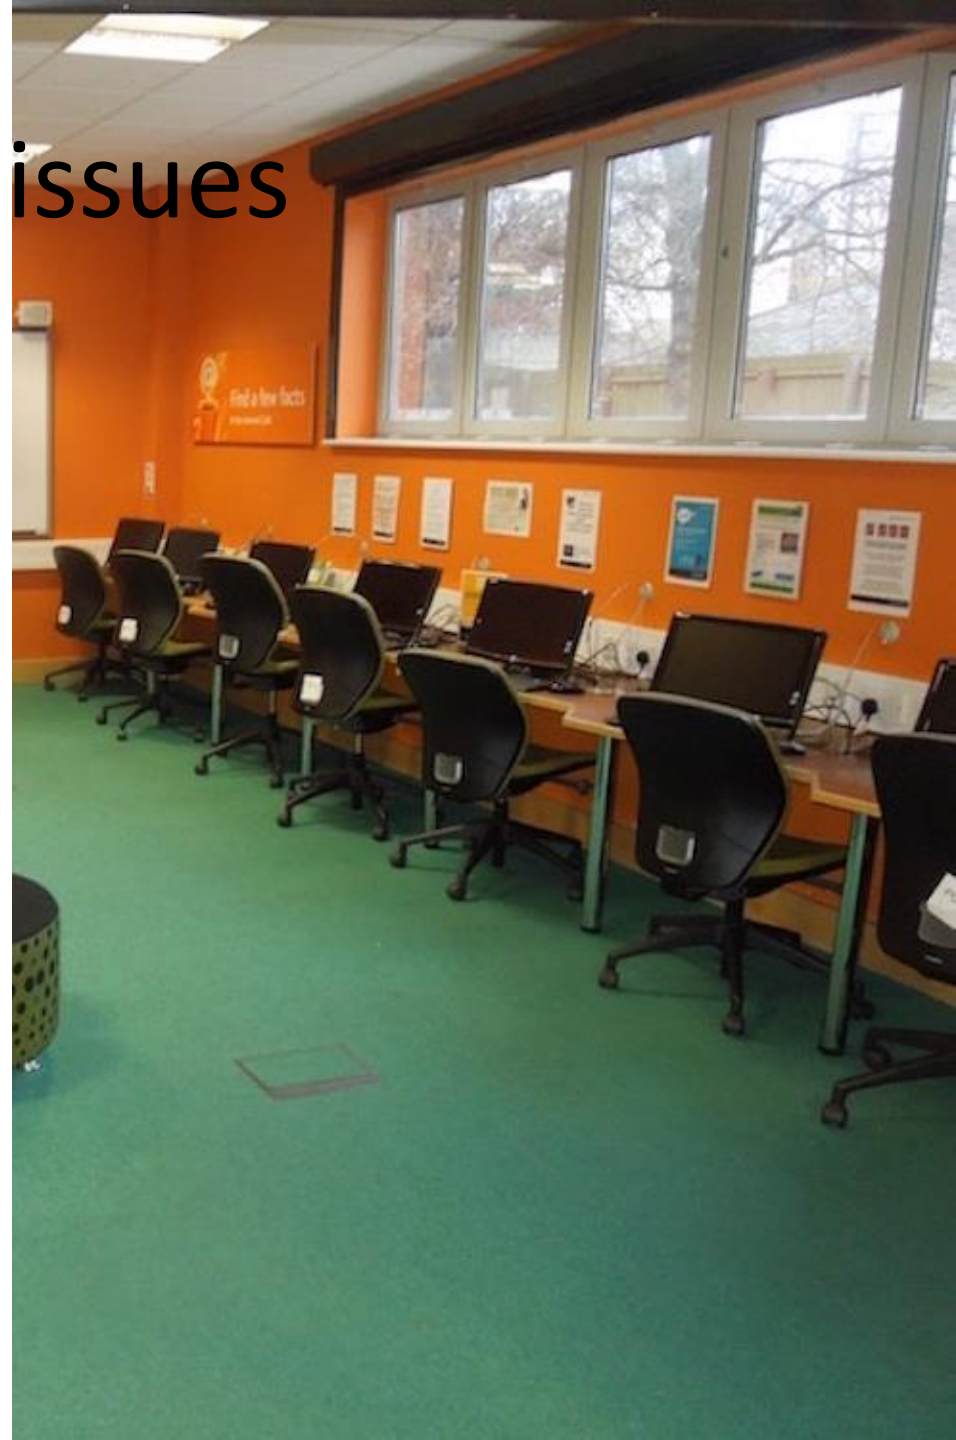
Other issues

- Computers 24/7/365
- BMS Zone pumps running in summer
- Temperature set points eg circulation area set to 21°C
- BMS access – ensuring users can change their settings in accordance with usage
